# ARBORIST REPORT

**Inspection date: 10 / 18 / 2018**

**RE: Existing trees located on the proposed new construction site located at  
103 El Nido Road, Portola Valley, Ca. 94304**

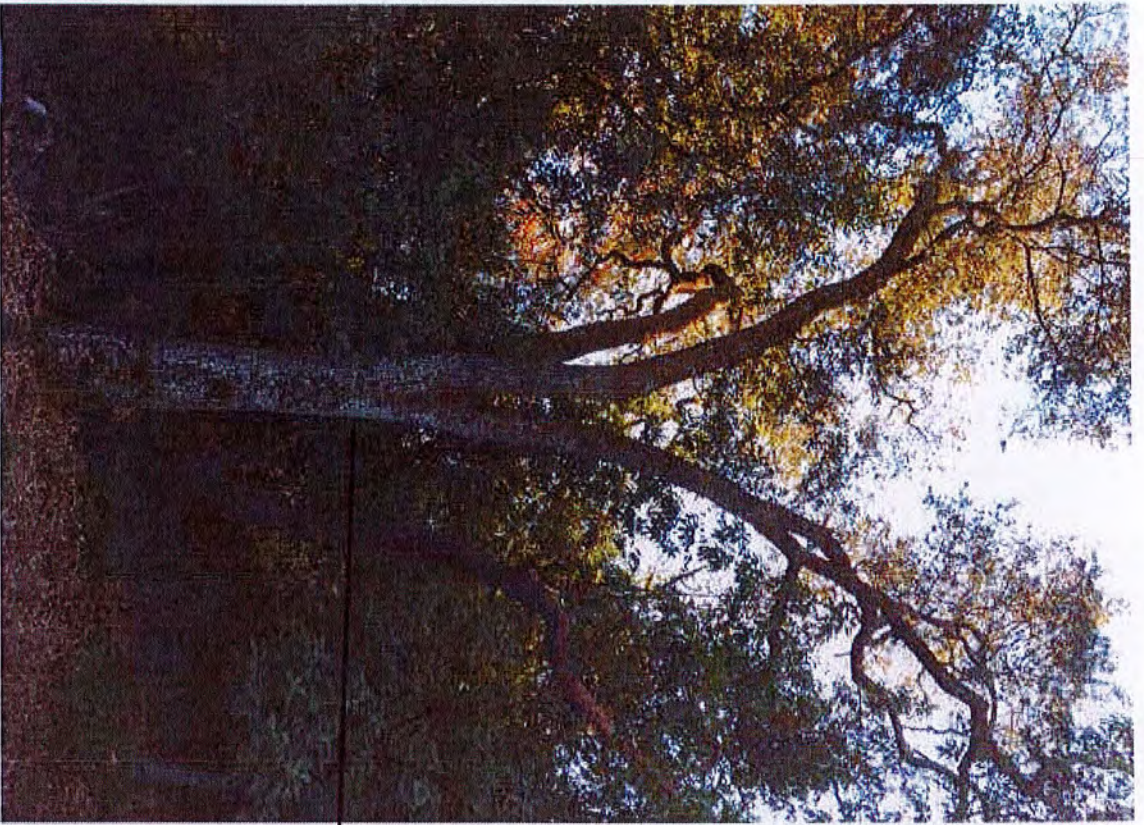
Exhibit 2-A

**Tree # 1 - Black Oak (*Quercus kelloggii*) with a d.b.h. of 21" and approximately 70' tall. Foliage color appears normal and foliage density appears fair. (Exhibit 1 - A, E)**

**Tree # 1 - Black Oak is located approximately 5' from the foundation of the proposed new construction and would incur root loss jeopardizing tree stability.**

**Tree # 1 - Black Oak**

**Should be removed to abate any future risk of failures and to accommodate the proposed new construction site.**

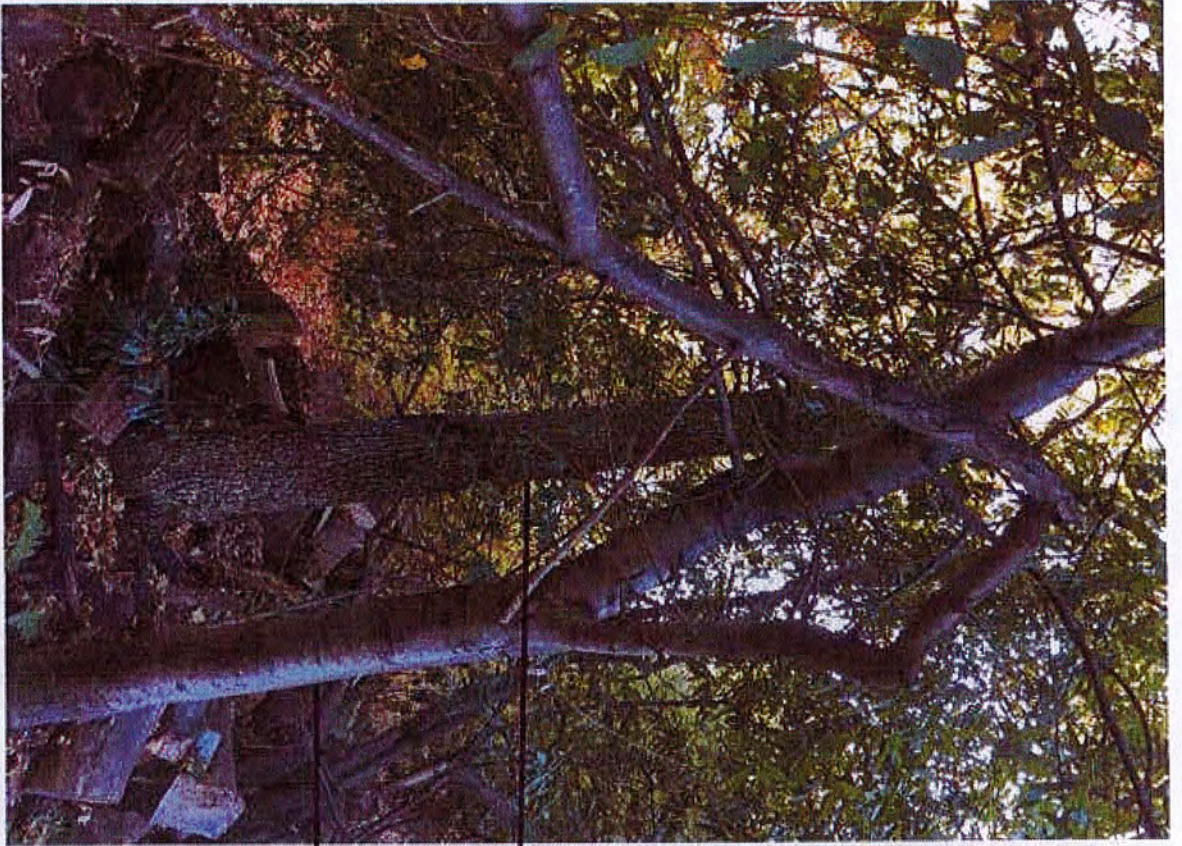
EXHIBIT 1-E

**Tree # 3 - California Bay Laurel (*Umbellularia californica*) with a d.b.h. of 7" and approximately 20' tall with an excessive lean downhill. Foliage color appears fair and foliage density appears sparse. Decay is present on the main stem @ 10". (Exhibit 3 - C, D) (Exhibit 1-E)**

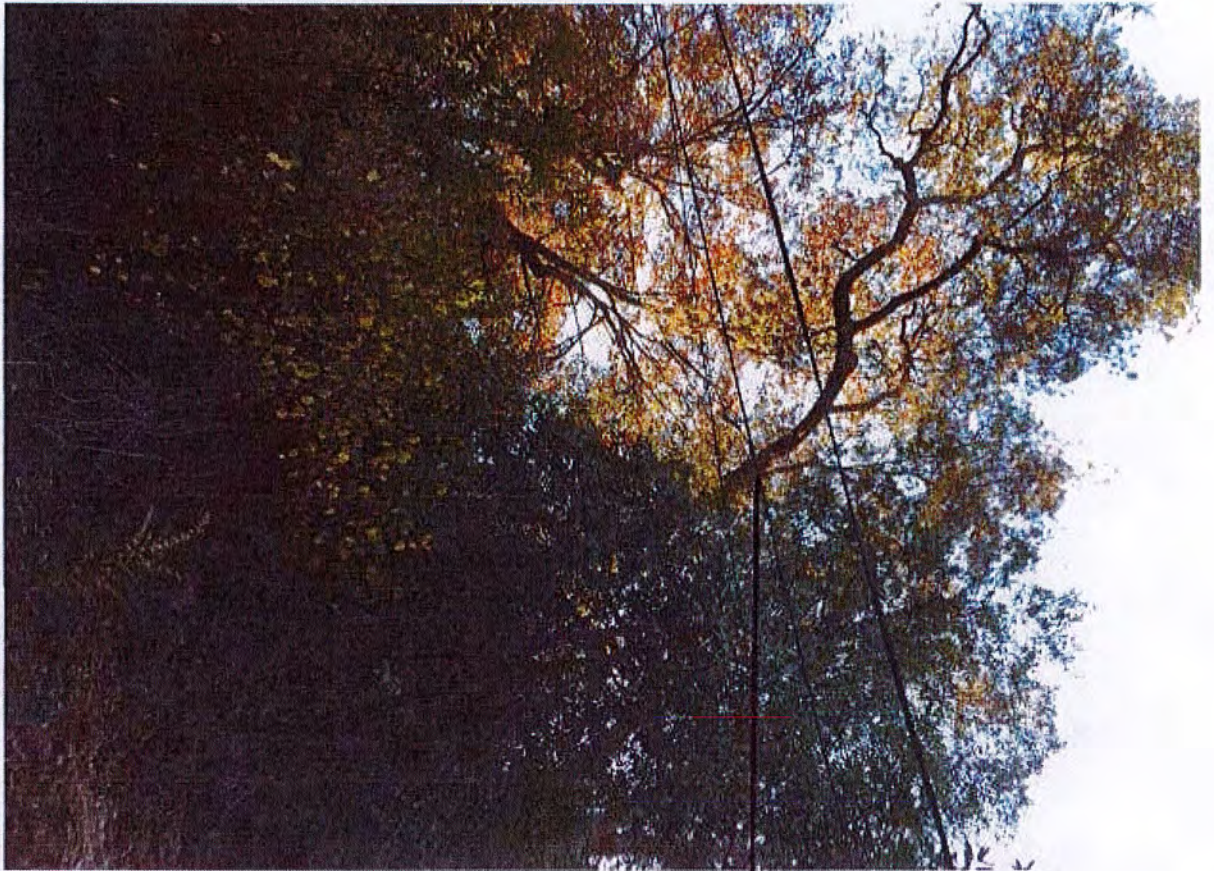
Exhibit 2-B

**Tree # 2 - Black Oak with a d.b.h. of 16" and approximately 70' tall. Foliage color appears normal and foliage density appears fair. The tree bows at midway with an excessive lean over the neighbor's driveway and utility lines along the roadway below. (Exhibit 2 -B)**

**Tree # 2 - Black Oak proposes the risk of failure with excessive weight beyond the bow in the main stem and an excessive lean over the neighbor's driveway and utility lines along the roadway.**

**Tree # 2 - Black Oak**

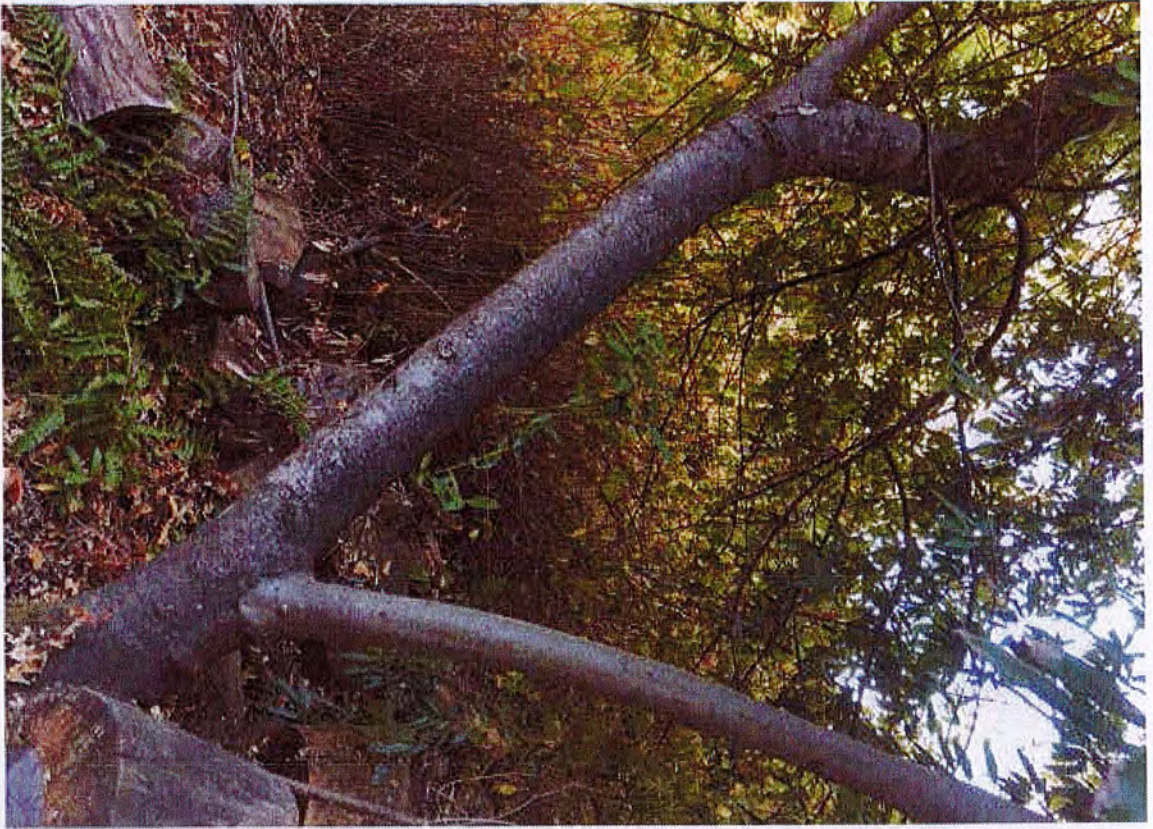
Exhibit 3-C

**Tree # 3 - California Bay Laurel is diseased with decay present in the main stem.**

**Tree # 3 - Bay Laurel**

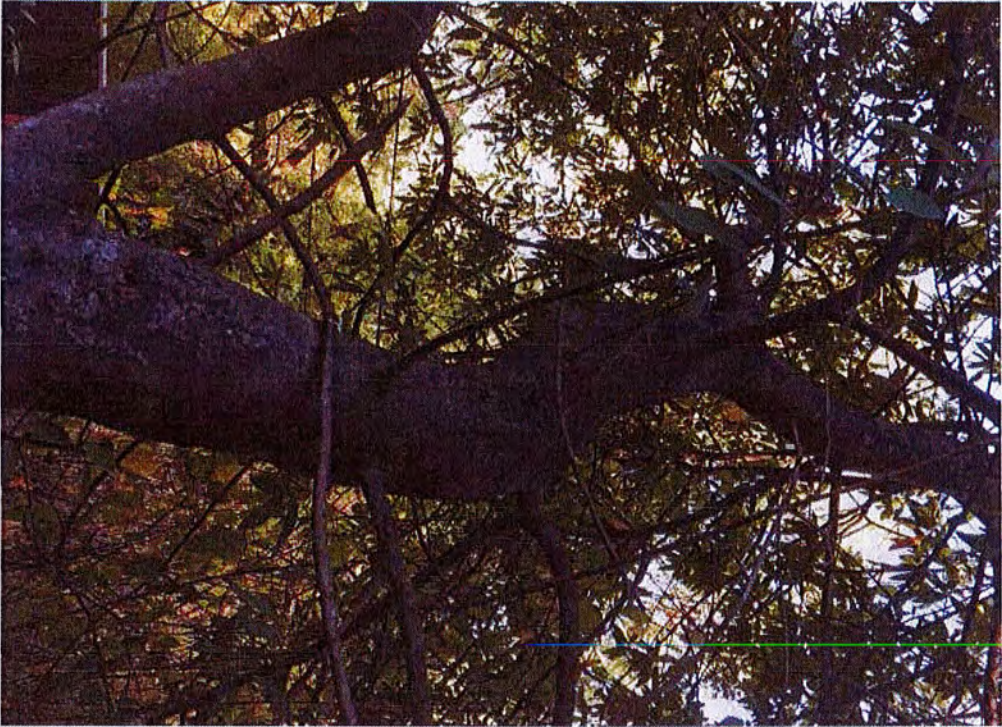
Exhibit 4-F

**Tree # 4 – Madrone (*Arbutus menziesii*) with a d.b.h. of 10" and approximately 30' tall. Foliage color appears fair and foliage density appears sparse. The tree has an excessive lean and a crook in the main stem @ 15'. The base of the tree exhibits excessive decay. (Exhibit 4 - F, G)**

**Tree # 4 - Madrone is diseased with excessive decay present at the base of the tree.**

**Tree # 4 - Madrone**

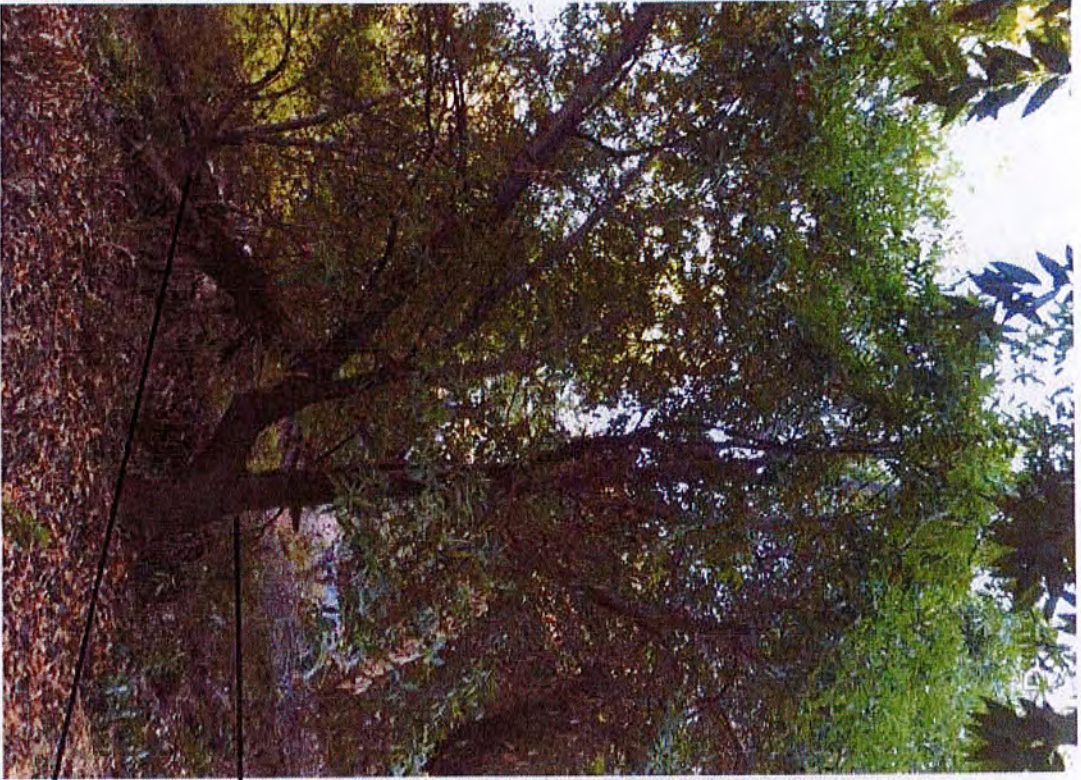
Exhibit 5-H

**Tree # 5 – California Bay Laurel with a d.b.h. of 7" and approximately 20' tall. Foliage color appears fair and foliage density appears sparse. The base of the tree exhibits excessive decay. (Exhibit 5 - H, I)**

**Tree # 7 – California Bay Laurel with a co-dominant structure both main stems measured and added together with a d.b.h. of 21" and approximately 25' tall. Foliage color appears fair and foliage density appears fair. The tree appears to have been recently topped. The base and main stem exhibit decay. (Exhibit 7-K) (Exhibit 5- H)**

**Tree # 5 - California Bay Laurel is diseased with excessive decay present at the base of the tree.**

**Tree # 5 - Bay Laurel**

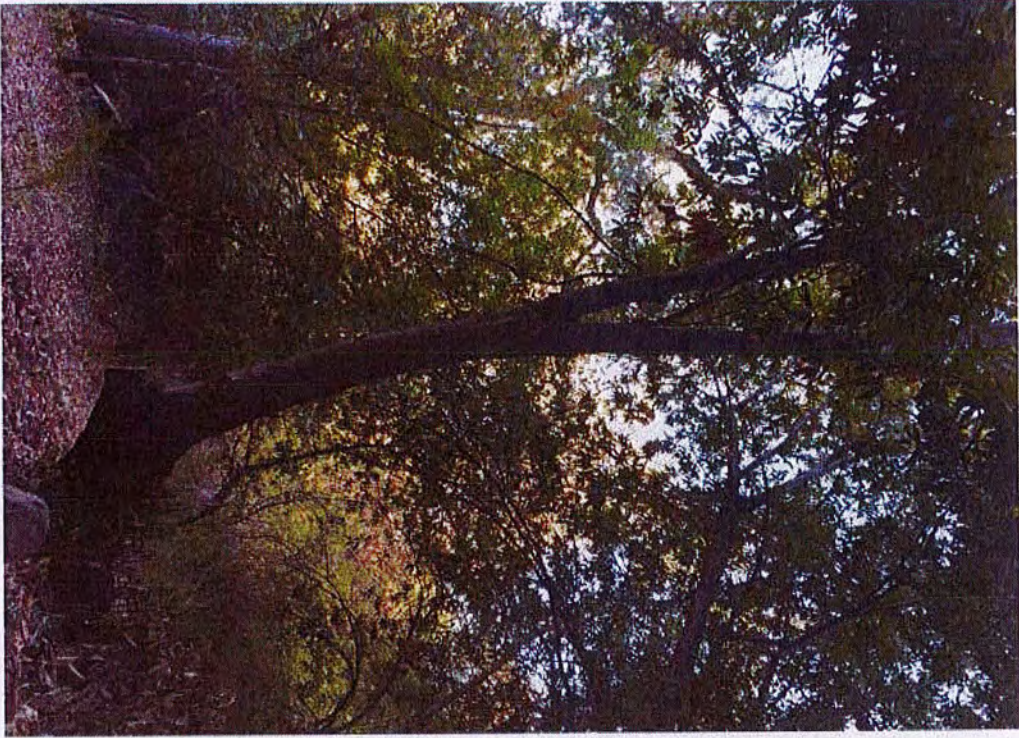
Exhibit 6-5

**Tree # 6 – California Bay Laurel with a d.b.h. of 9" and approximately 30' tall. The tree has been previously topped @ 10' with 2 main stems extending from topping cut 20' upwards. (Exhibit 6 - J)**

**Tree # 6 - California Bay Laurel is predisposed to failure at the 10' topping cut where two new main stems have a weak attachment.**

**Tree # 6 - Bay Laurel**

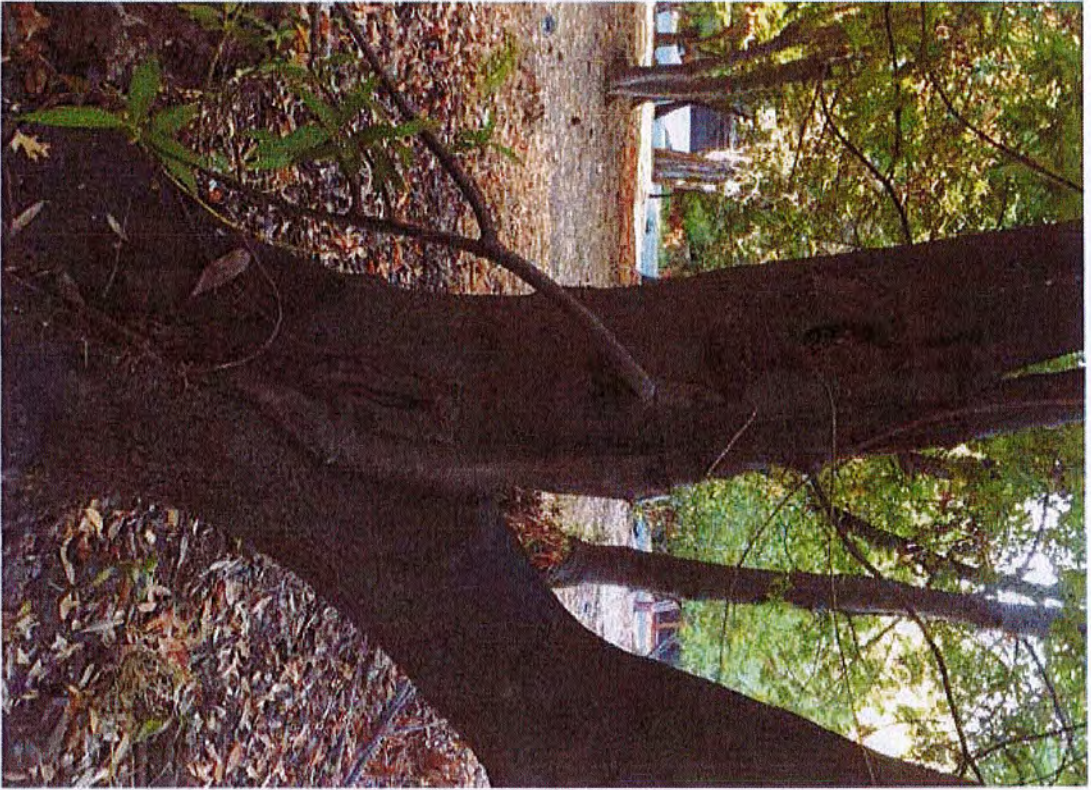
Exhibit 7-K

**Tree # 7 - California Bay Laurel is diseased with multiple areas of decay present at the base and on the main stem.**

**Tree # 7 - Bay Laurel**

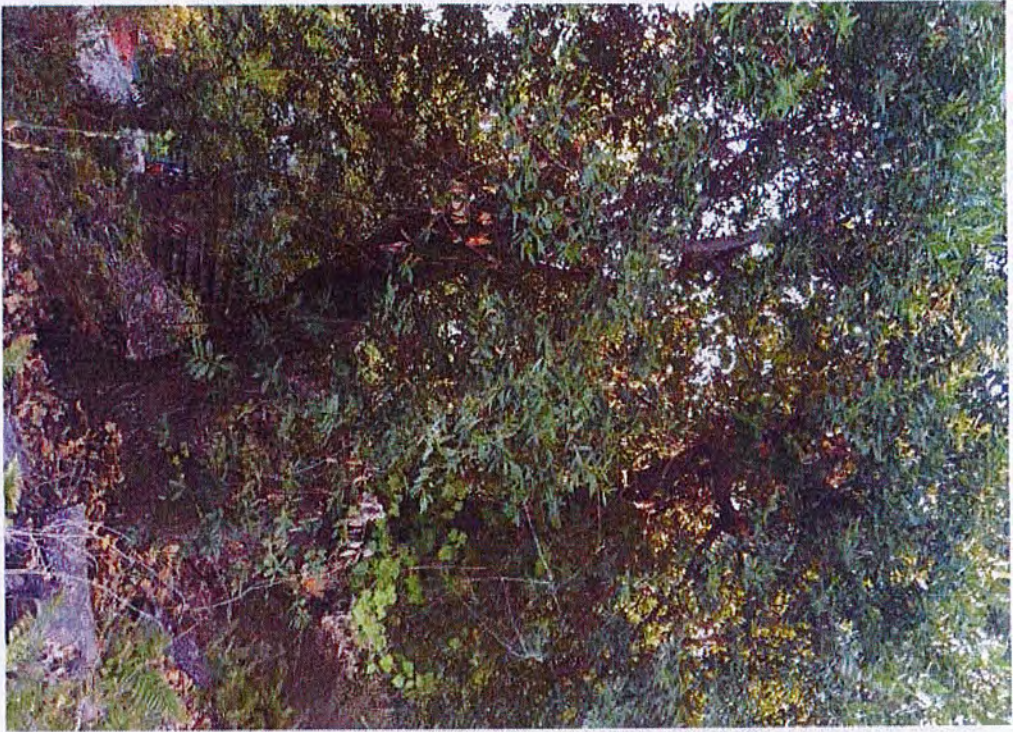
Exhibit 8-1

f  
**Tree # 8 – California Bay Laurel with a co-dominant structure at the base and added together with a d.b.h. of 38" and approximately 40' tall. Foliage color appears fair and foliage density appears fair. The tree has been previously topped @ 15' and 30' with a large tear on the main stem from the topping cut @ 15'. Half of the tree is overgrown with Ivy. (Exhibit 8 - L, M, N)**

**Tree # 8 - California Bay Laurel proposes a risk at the topping cuts where decay is present on one main stem and any new growth has a weak attachment on both main stems.**

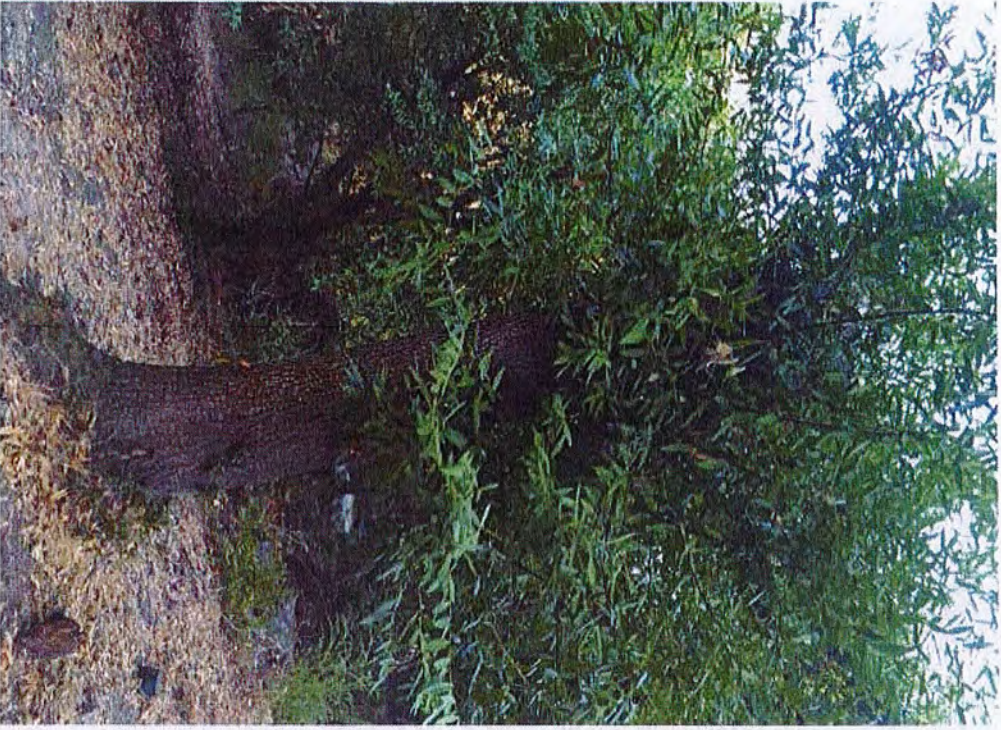
Exhibit 9-0

f  
**Tree # 9 – California Bay Laurel with a d.b.h. of 20" and approximately 20' tall. Foliage color appears normal and foliage density appears sparse. The tree has been previously topped @ 15' with new sucker shoots extending 5' from the main stem. (Exhibit 9 - O)**

**Tree # 9 – California Bay Laurel has a weak attachment of new growth from the topping cut @ 15’.**

**Tree # 9 - Bay Laurel**

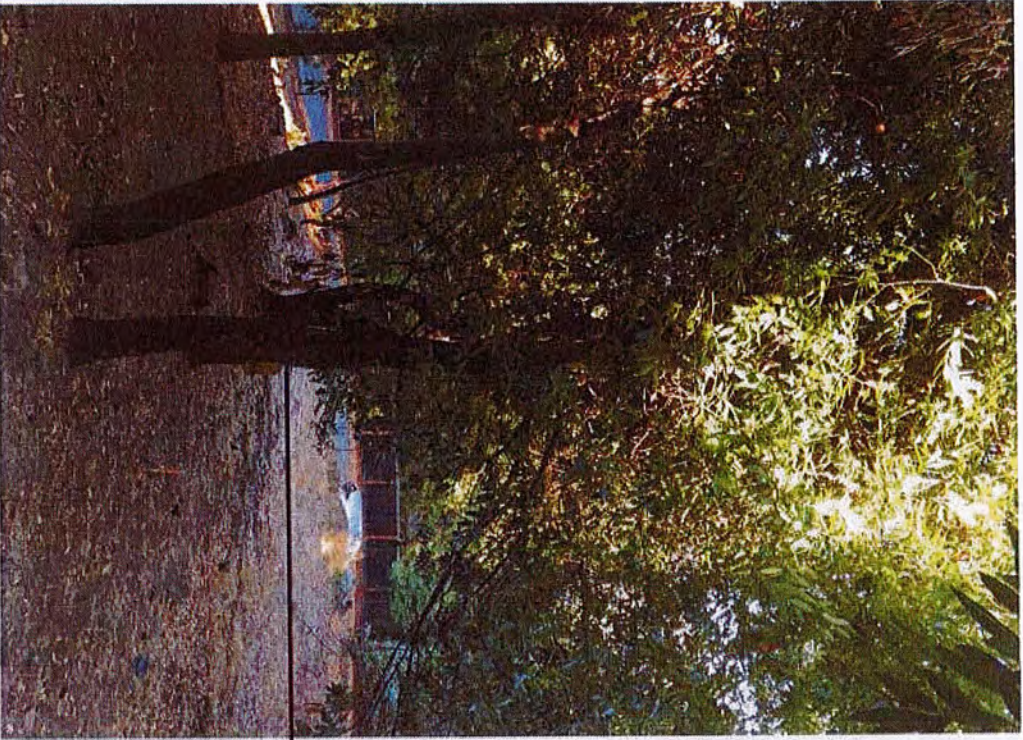
Exhibit 10-P

**Tree # 10 – California Bay Laurel with a d.b.h. of 8" and approximately 30' tall. Foliage color appears normal and foliage density appears fair. The tree is located on the adjacent property with the dripline extending over the proposed new construction site. (Exhibit 10 - P)**

**Tree # 10 – California Bay Laurel is located on the adjacent property with the dripline extending into the proposed new construction site and should have a Tree Protection Zone installed at the dripline overhanging the new construction site if the tree is to be preserved to minimize soil compaction and main stem injury.**

**Tree # 10 - Bay Laurel**

**SHALL have a Tree Protection Zone installed if any of these trees are to remain on site for the duration of the project.**

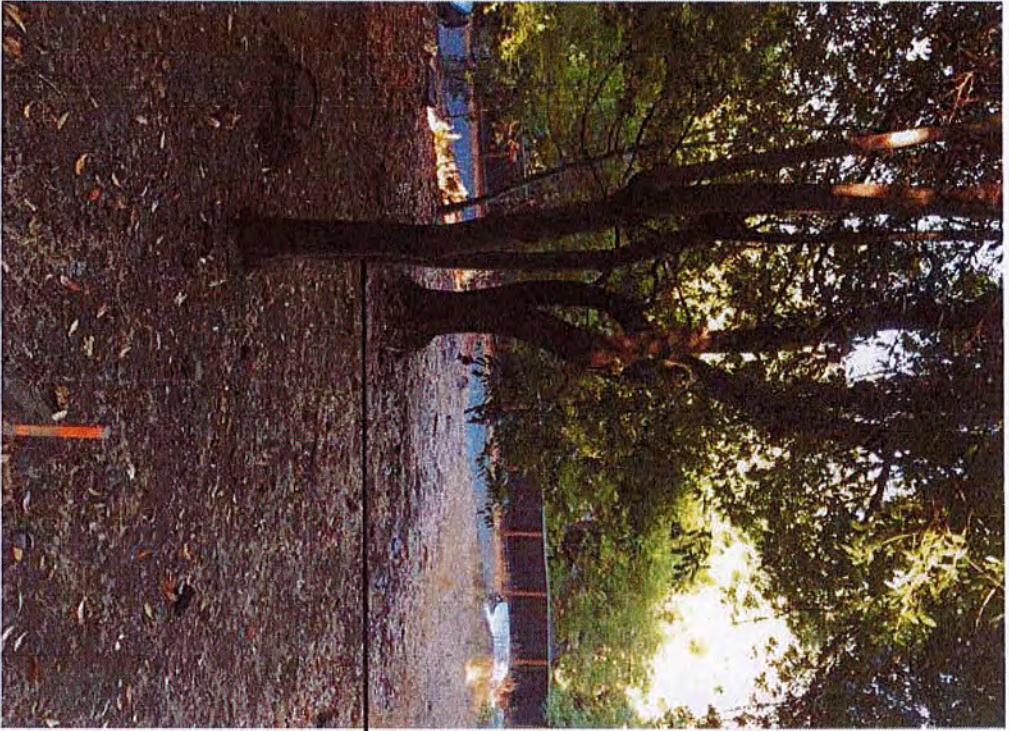
Exhibit 11-a

**Tree # 11 – California Bay Laurel with a co-dominant structure measured and added together with a d.b.h. of 9" and approximately 25' tall. Foliage color appears normal and foliage density appears fair. The tree has been previously topped @ 10' with new growth extending 20' upward from topping cut. The tree is located on the adjacent property with no dripline extending over the proposed new construction site. (Exhibit 11 - Q)**

**Tree # 11 – California Bay Laurel is located on the adjacent property with the dripline extending into the proposed new construction site and should have a Tree Protection Zone installed at the dripline overhanging the new construction site if the tree is to be preserved to minimize soil compaction and main stem injury.**

**Tree # 11 - Bay Laurel**

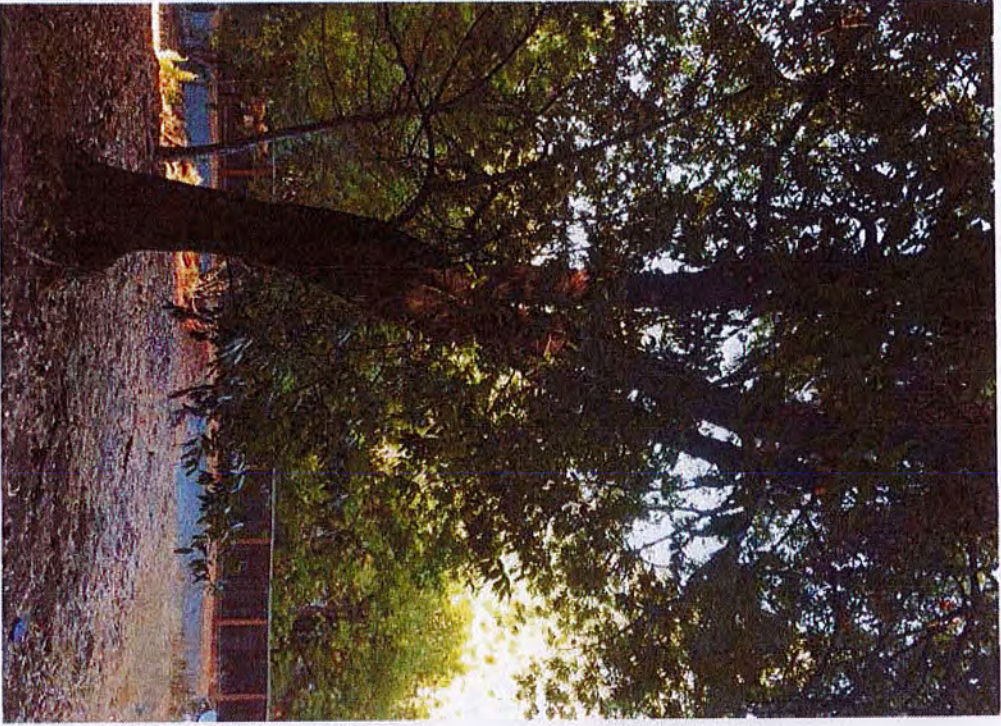
Exhibit 12-R

X **Tree # 12 - California Bay Laurel with a co-dominant structure measured and added together with a d.b.h. of 26" and approximately 30' tall. Foliage color appears normal and foliage density appears normal. The tree is located on the adjacent property with the dripline extending over the proposed new construction site. (Exhibit 12 - R)**

**Tree # 12 – California Bay Laurel is located on the adjacent property with the dripline extending into the proposed new construction site and should have a Tree Protection Zone installed at the dripline overhanging the new construction site if the tree is to be preserved to minimize soil compaction and main stem injury.**

**Tree # 12 - Bay Laurel**

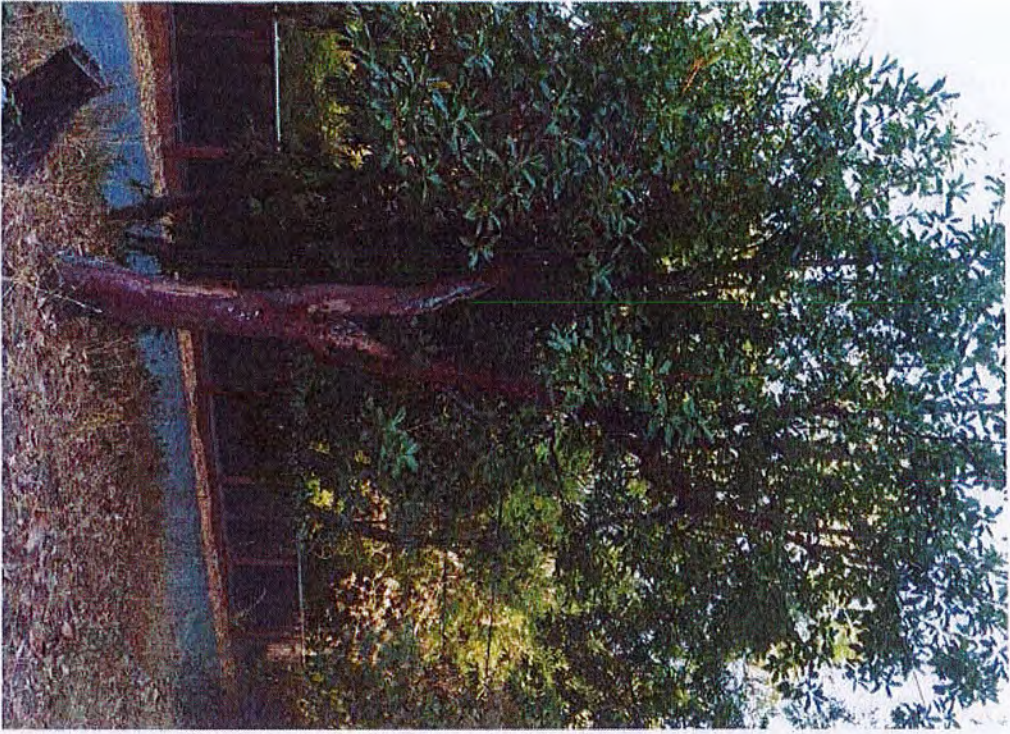
Exhibit 13-S

X **Tree # 13 - Madrone with a d.b.h. of 12" and approximately 25' tall. Foliage color appears normal and foliage density appears normal. The tree is located on the hillside next to the roadway and has been previously topped @ 15' next to utility lines with new growth extending 10' upward. (Exhibit 13 - S)**

**Tree # 13 – Madrone is located on the front hillside of the proposed new construction site and should have a Tree Protection Zone installed at or beyond the dripline if the tree is to be preserved to minimize soil compaction and main stem injury.**

**Tree # 13 - Madrone**
