COUNTY OF SAN MATEO

Emerald Lake Heights
Sewer Maintenance District

SEWER MASTER PLAN

Prepared by:
Brown and Caldwell
December 1999

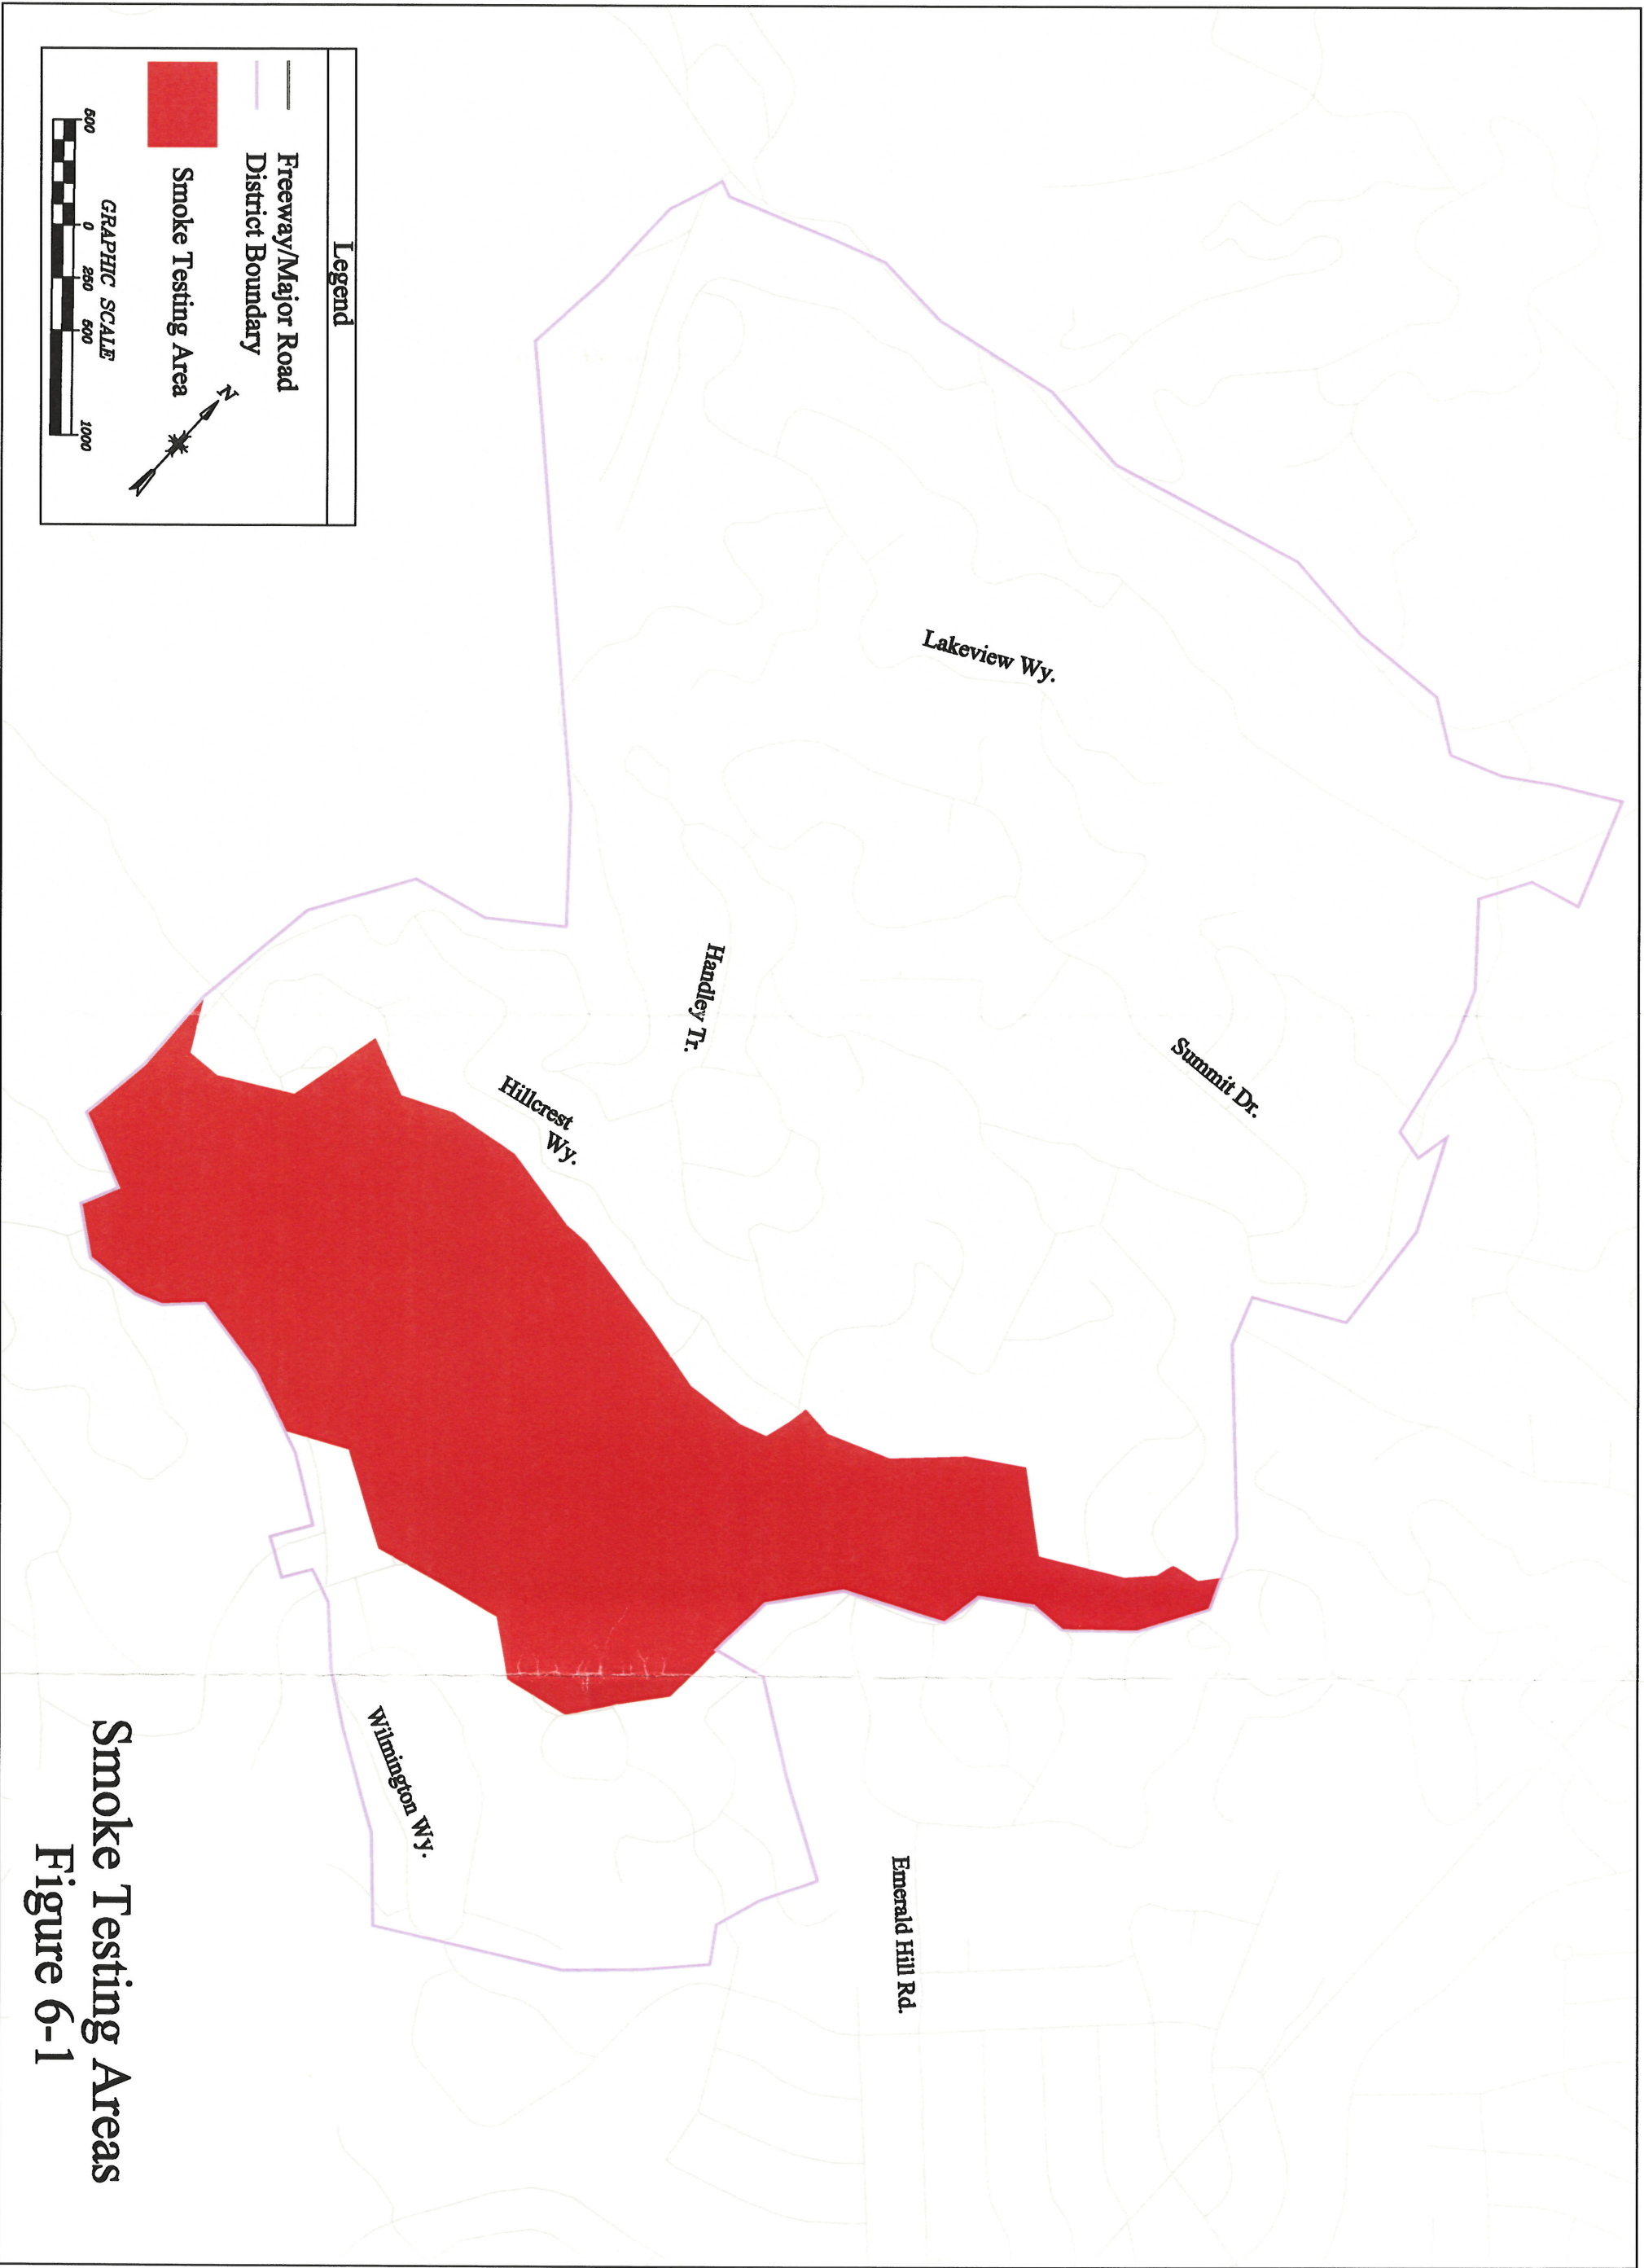
Smoke Testing Areas
Figure 6-1

No major defects were noted during the smoke testing program. A total of seven defects were located and documented during the program. The only defect noted during the program was missing or damaged cleanout covers. These defects are located on the private side of the property line. A summary of the smoke testing defects is provided in Table 6-1. A technical memorandum, dated October 13, 1998, describing the smoke testing program in more detail is provided in Appendix C. Smoke testing reports and photographs are also provided in Appendix C.

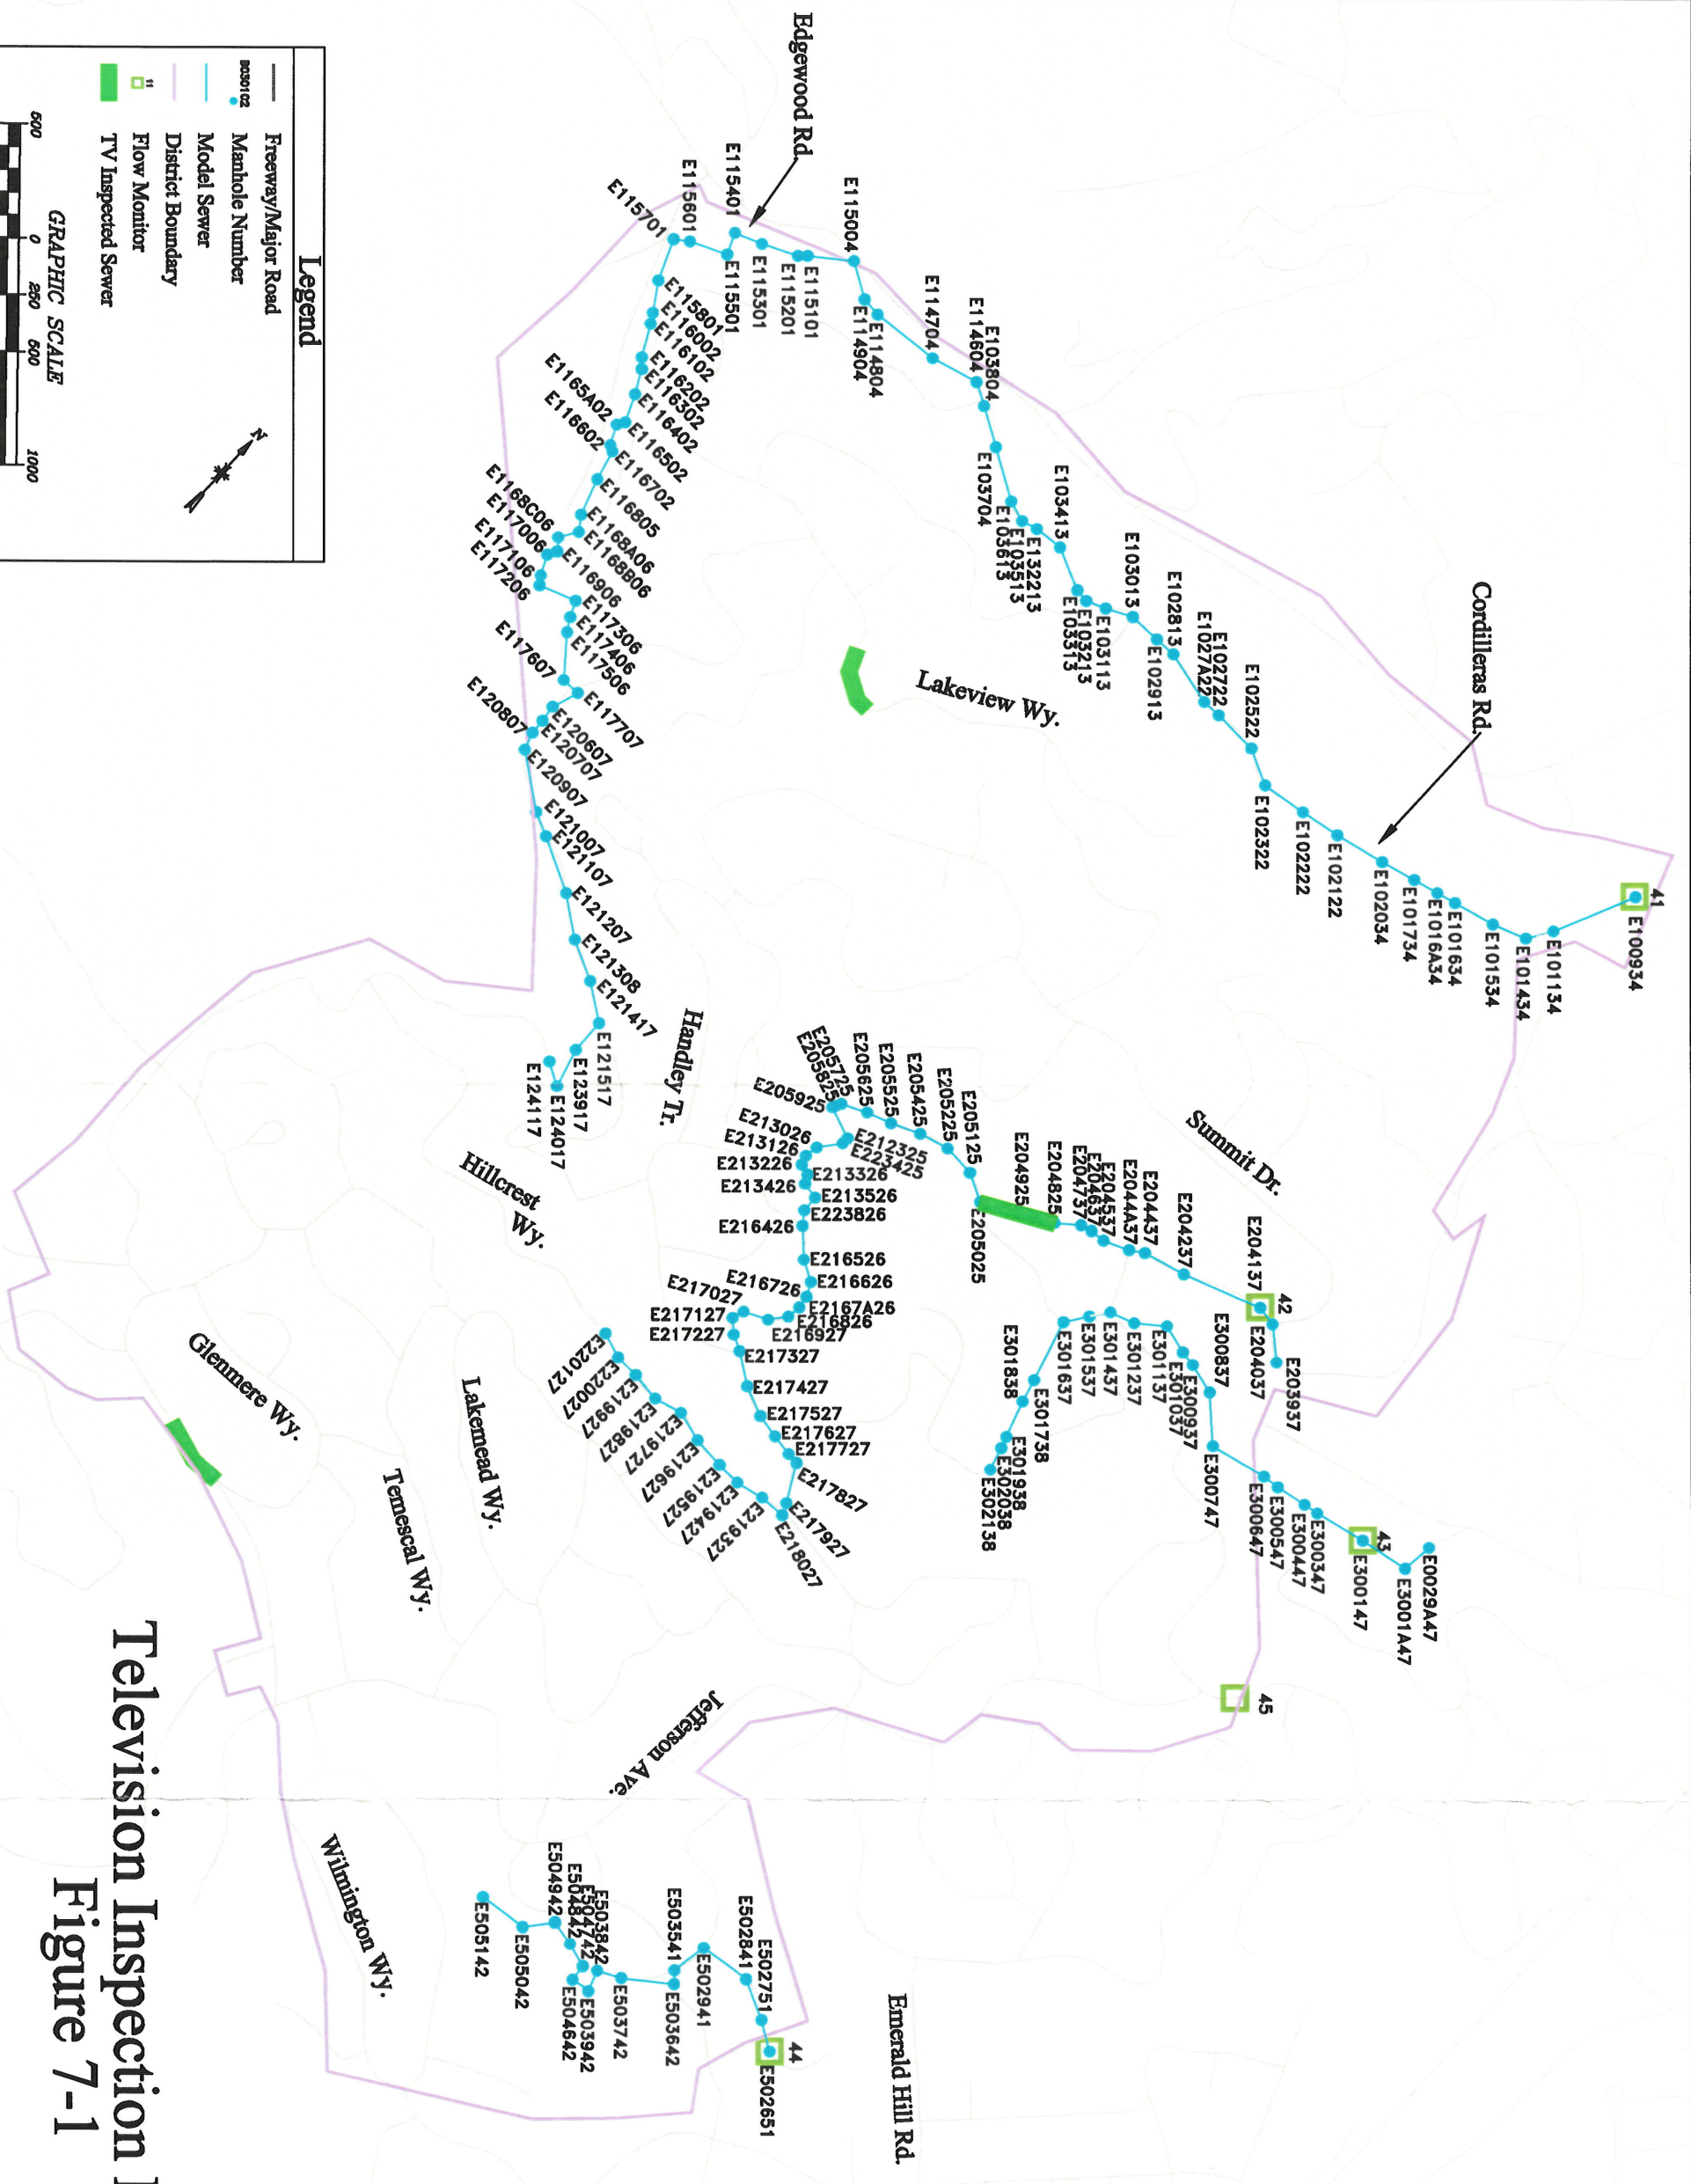
Television Inspection Program
Figure 7-1

Sewers scheduled for television inspection were cleaned or flushed prior to inspection to allow for a better structural inspection. Approximately 700 linear feet of mainline sewer could not be inspected due to severe defects in the line, which blocked the path of the camera, or lack of access to the sewer. When a severe defect was encountered, the camera setup was reversed to attempt an inspection of the sewer whenever possible. Results of the television inspection program are summarized in Table 7-1. Complete results of the program are provided in Appendix D.

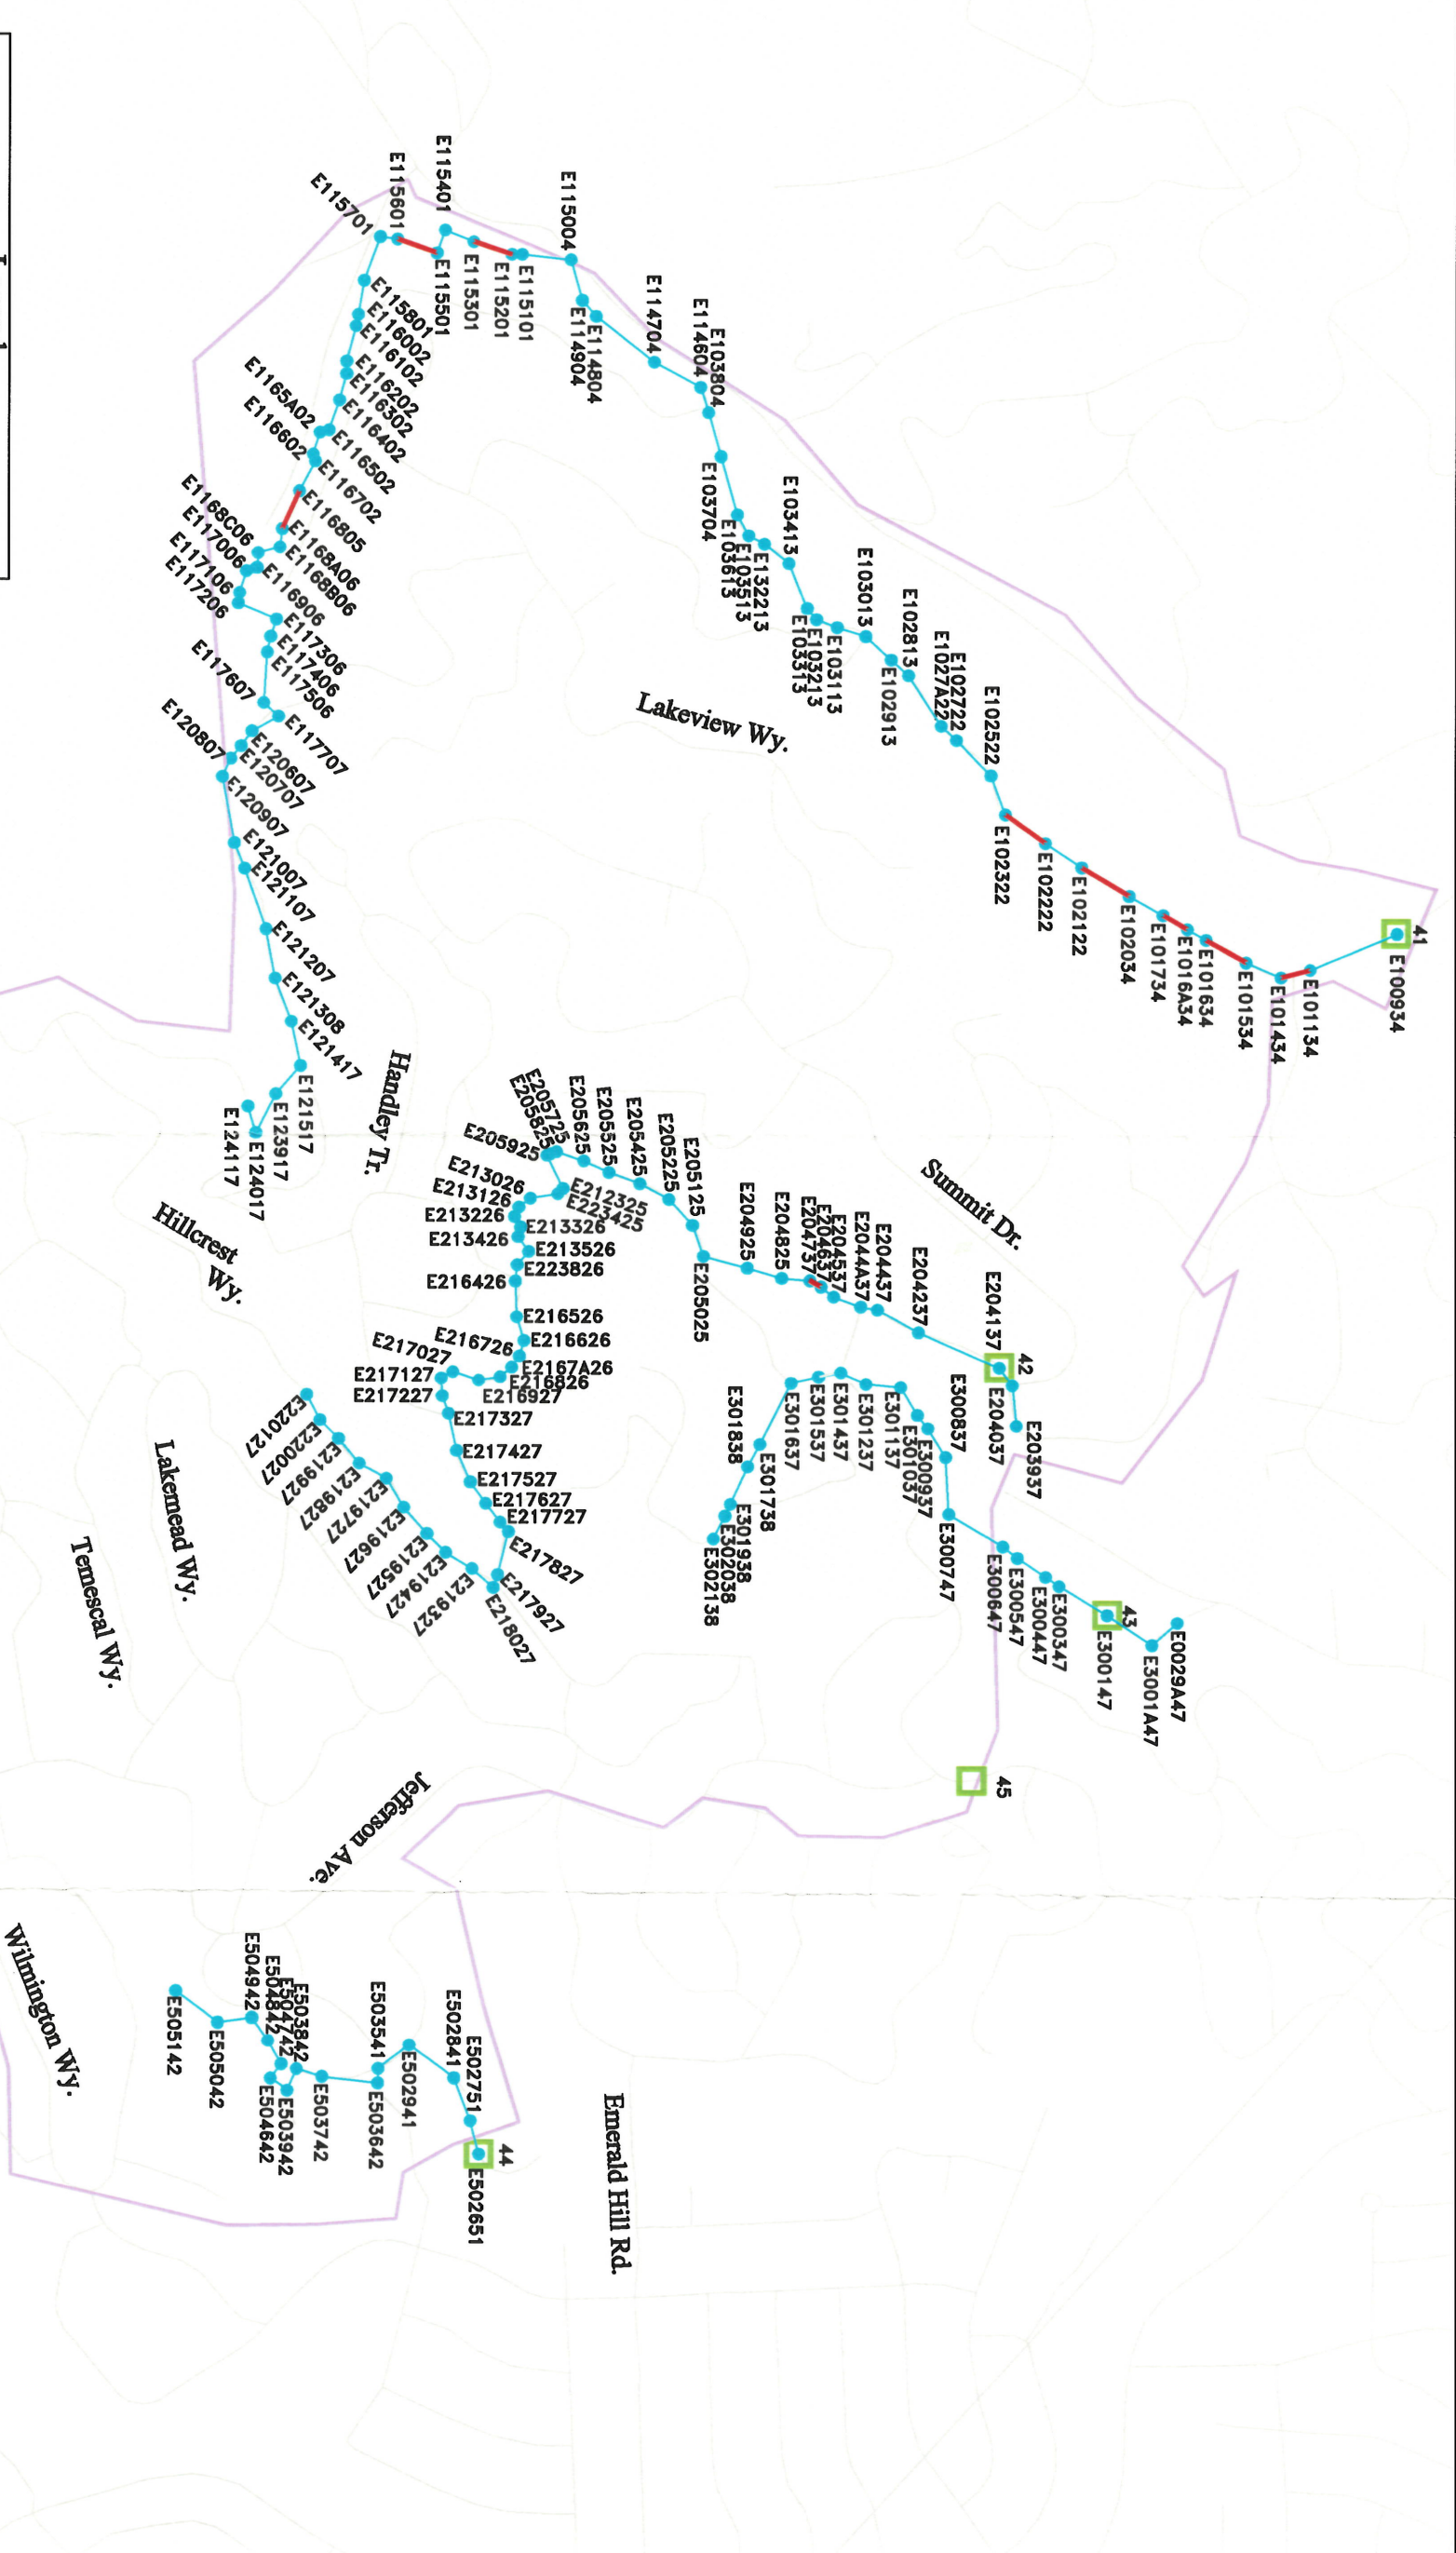
**Model Results
Figure 11-1**

The results of the model indicate two sections of the Cordilleras Road trunk sewer have insufficient capacity and are unable to convey peak wet weather flow without surcharging. Model results are shown on Figure 11-1. The technical memorandum describing the flow development and modeling is provided in Appendix E. Additionally, the complete HYDRA modeling results are provided in Appendix E.
