# State Route 1 Multi-Asset Roadway Rehabilitation Project

## **Aquatic Resource Delineation**

SAN MATEO COUNTY, CALIFORNIA

04-01-SM-PM 27.5/34.8

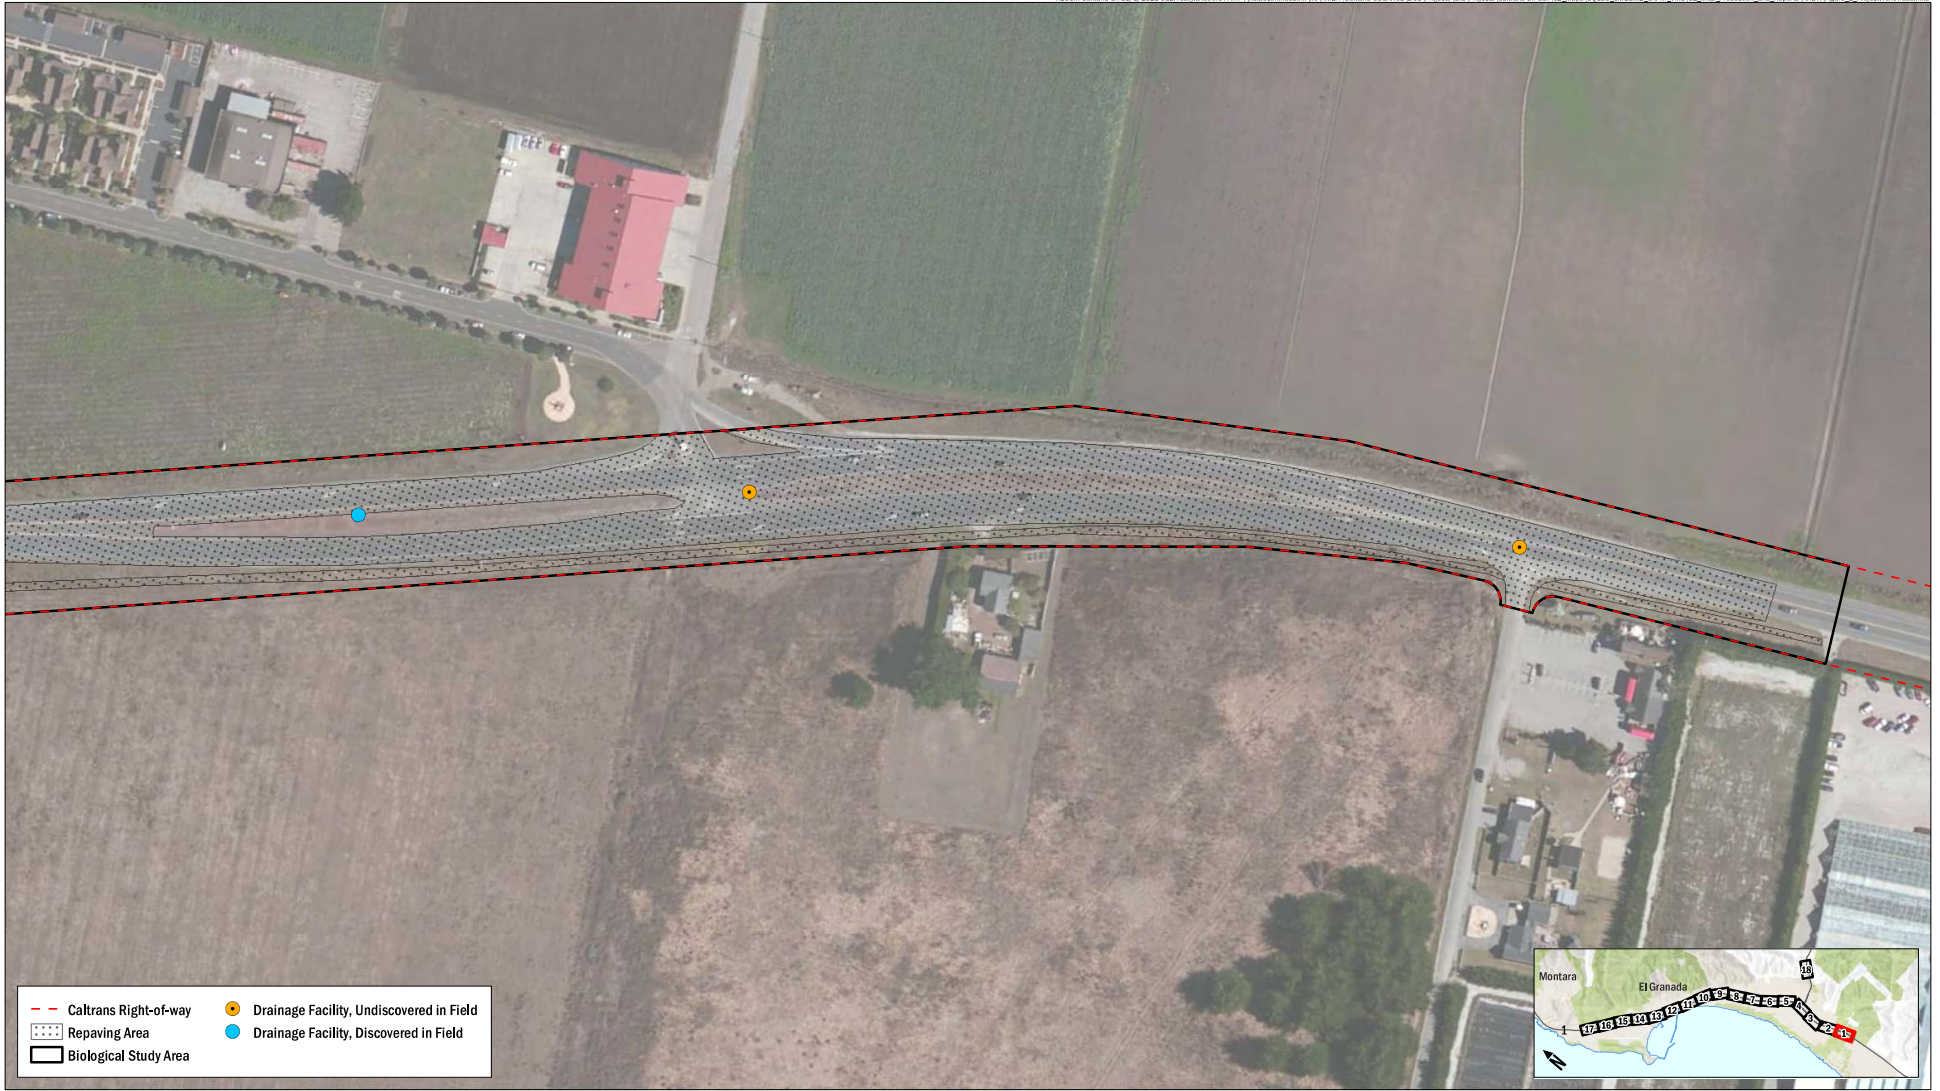
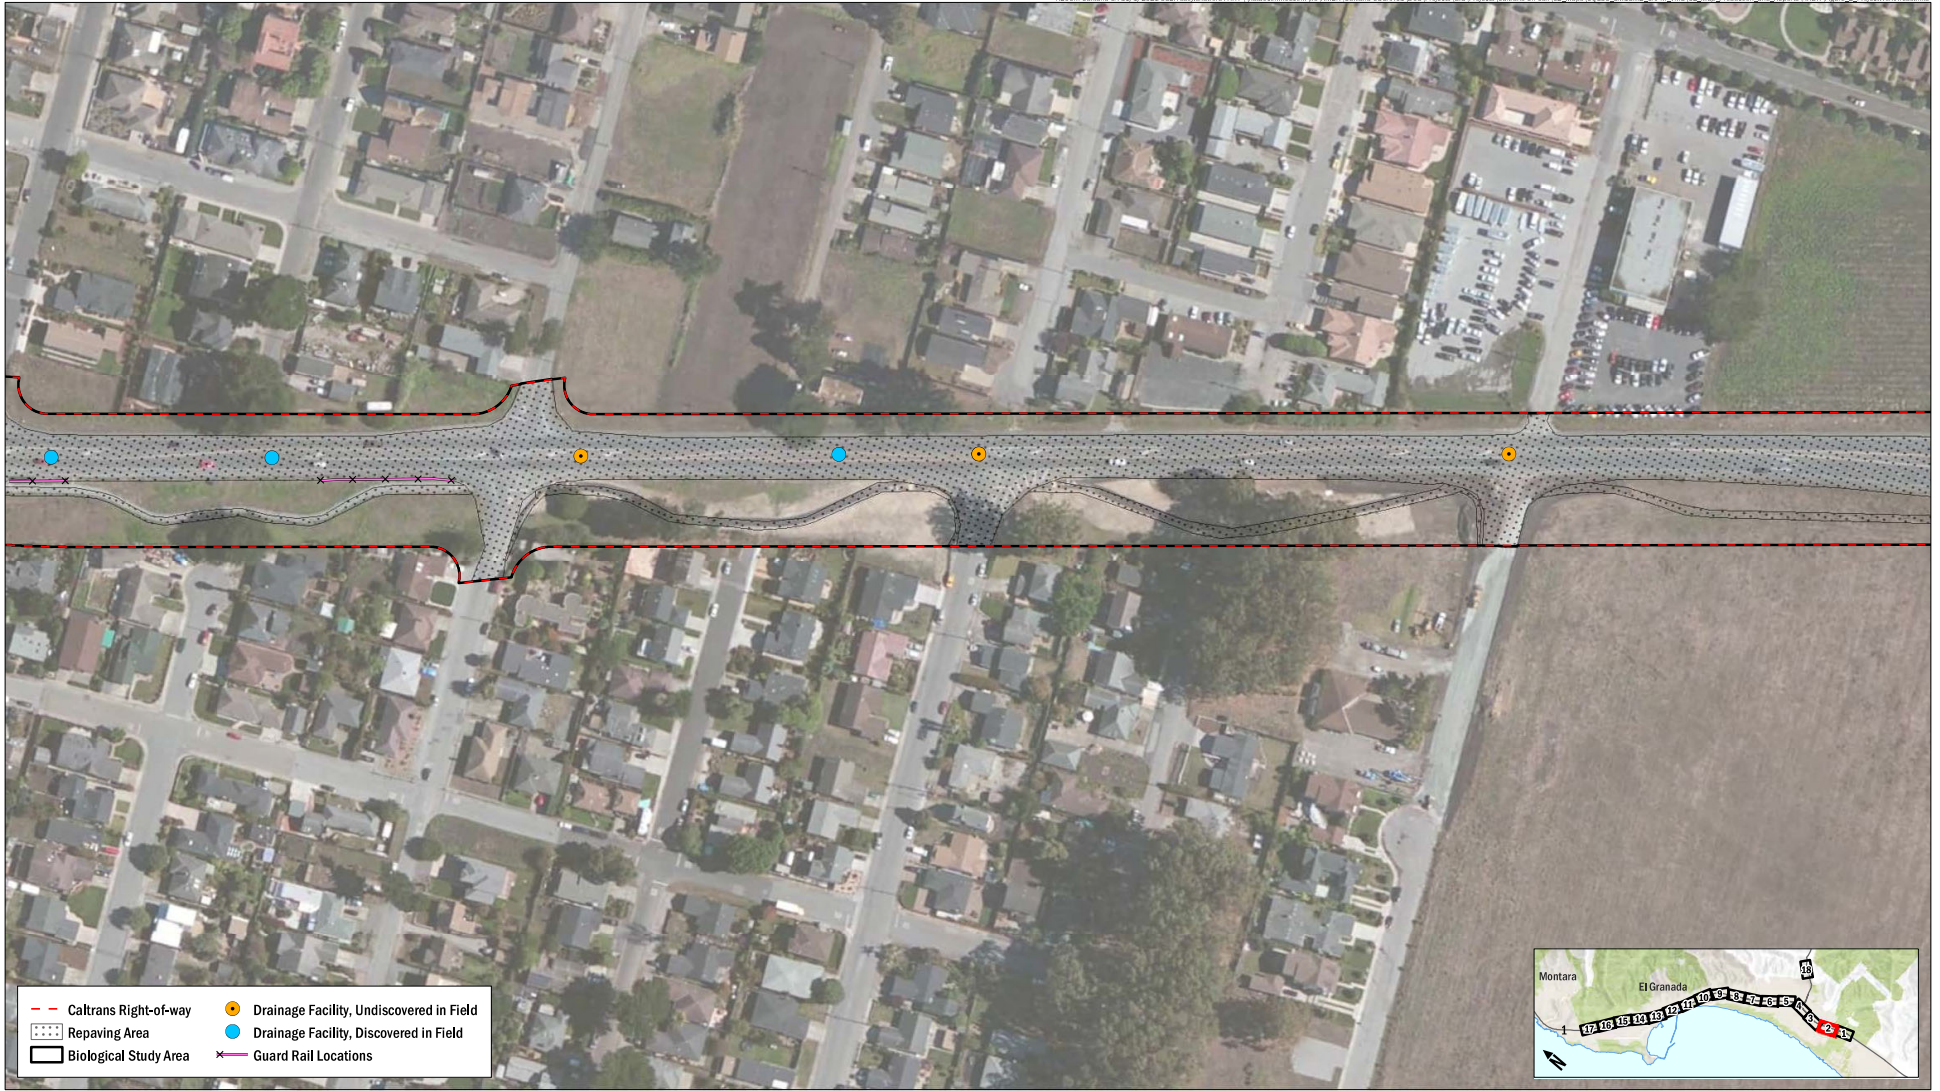
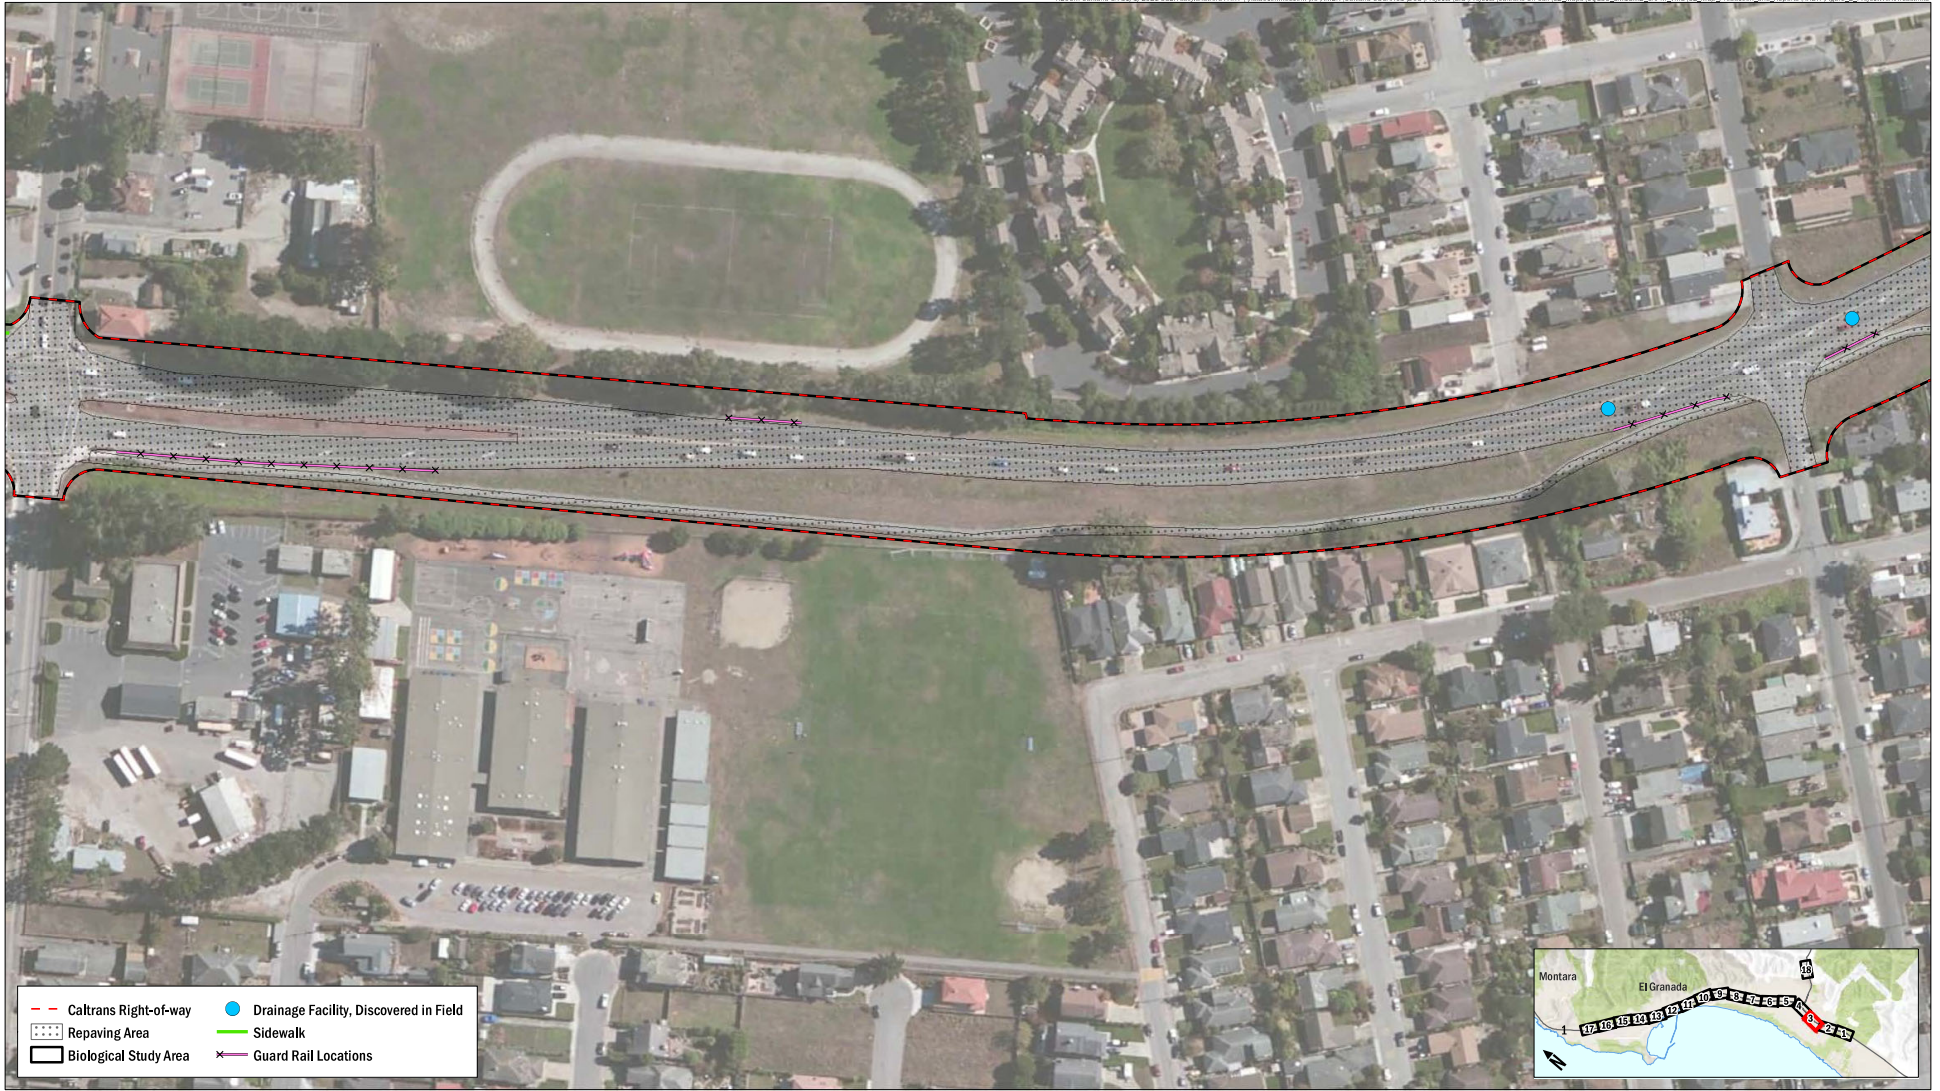
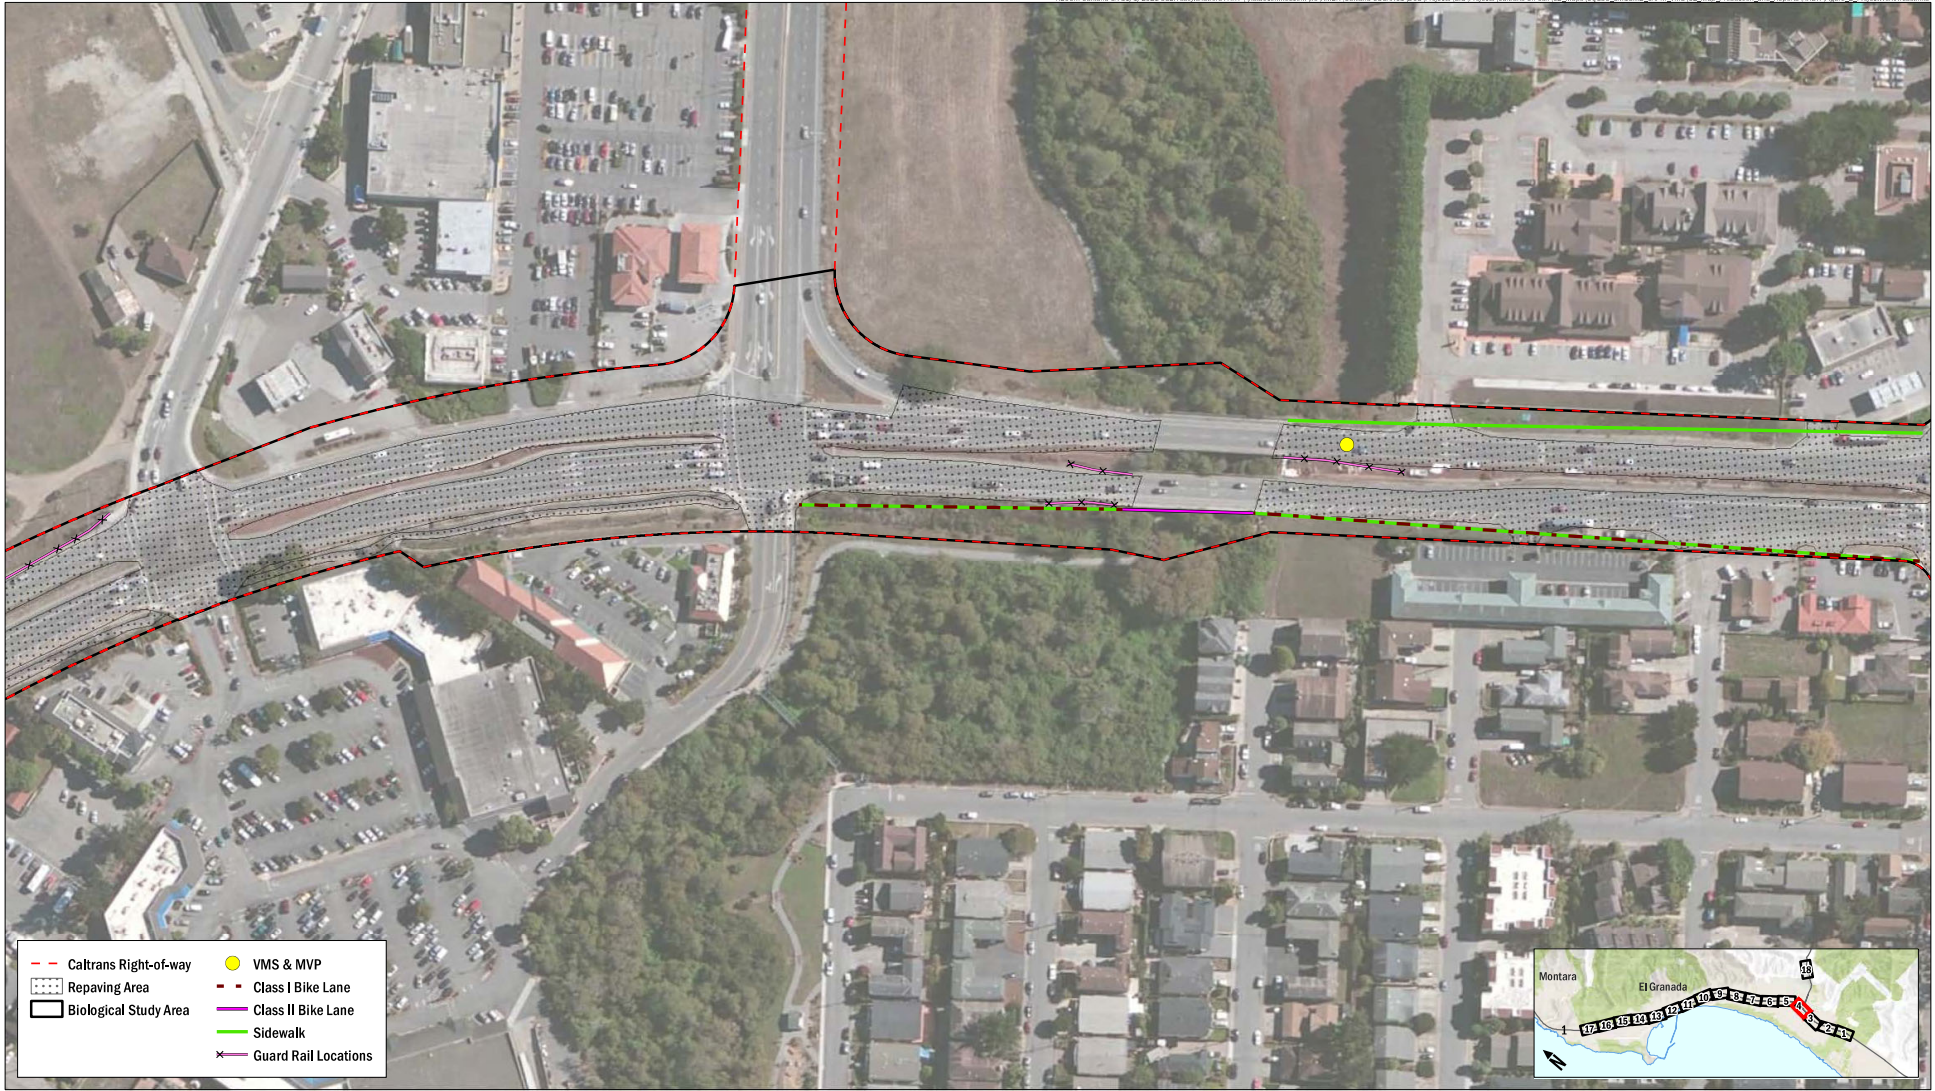
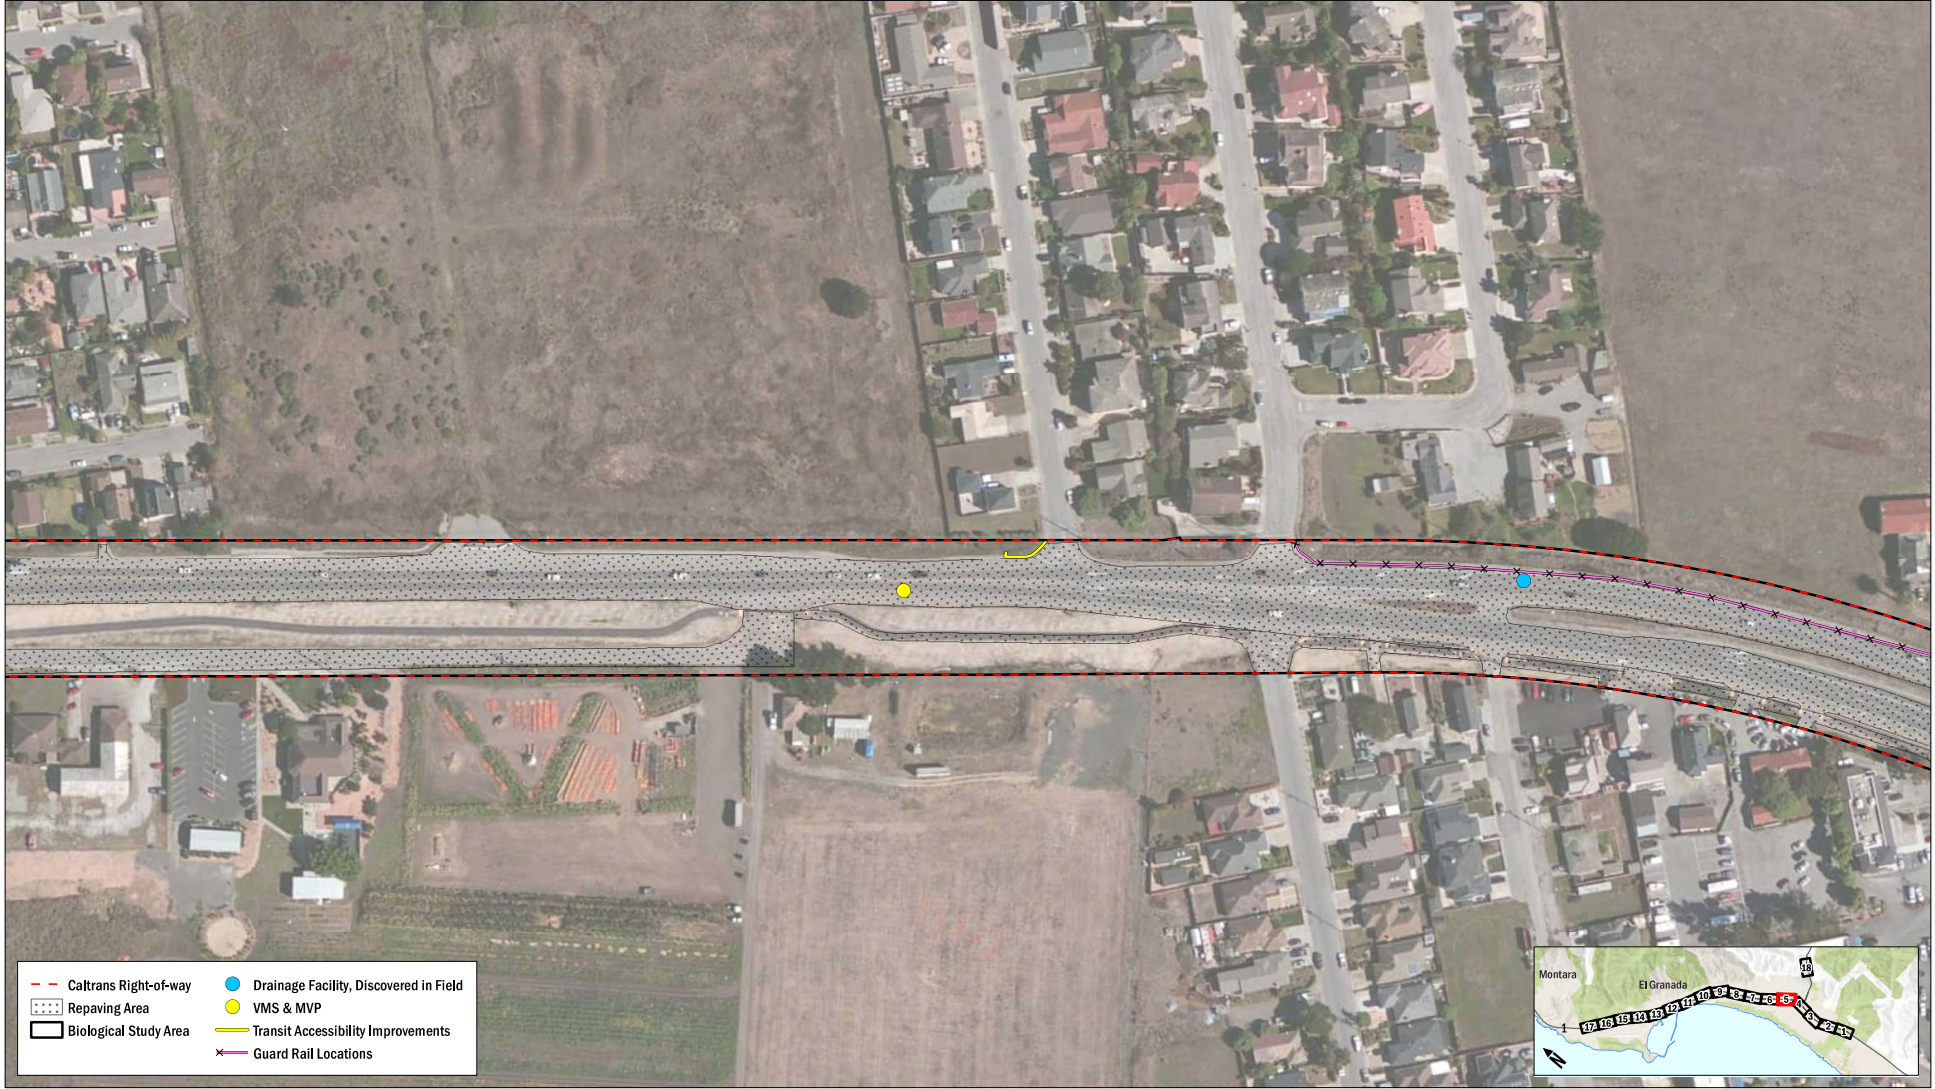
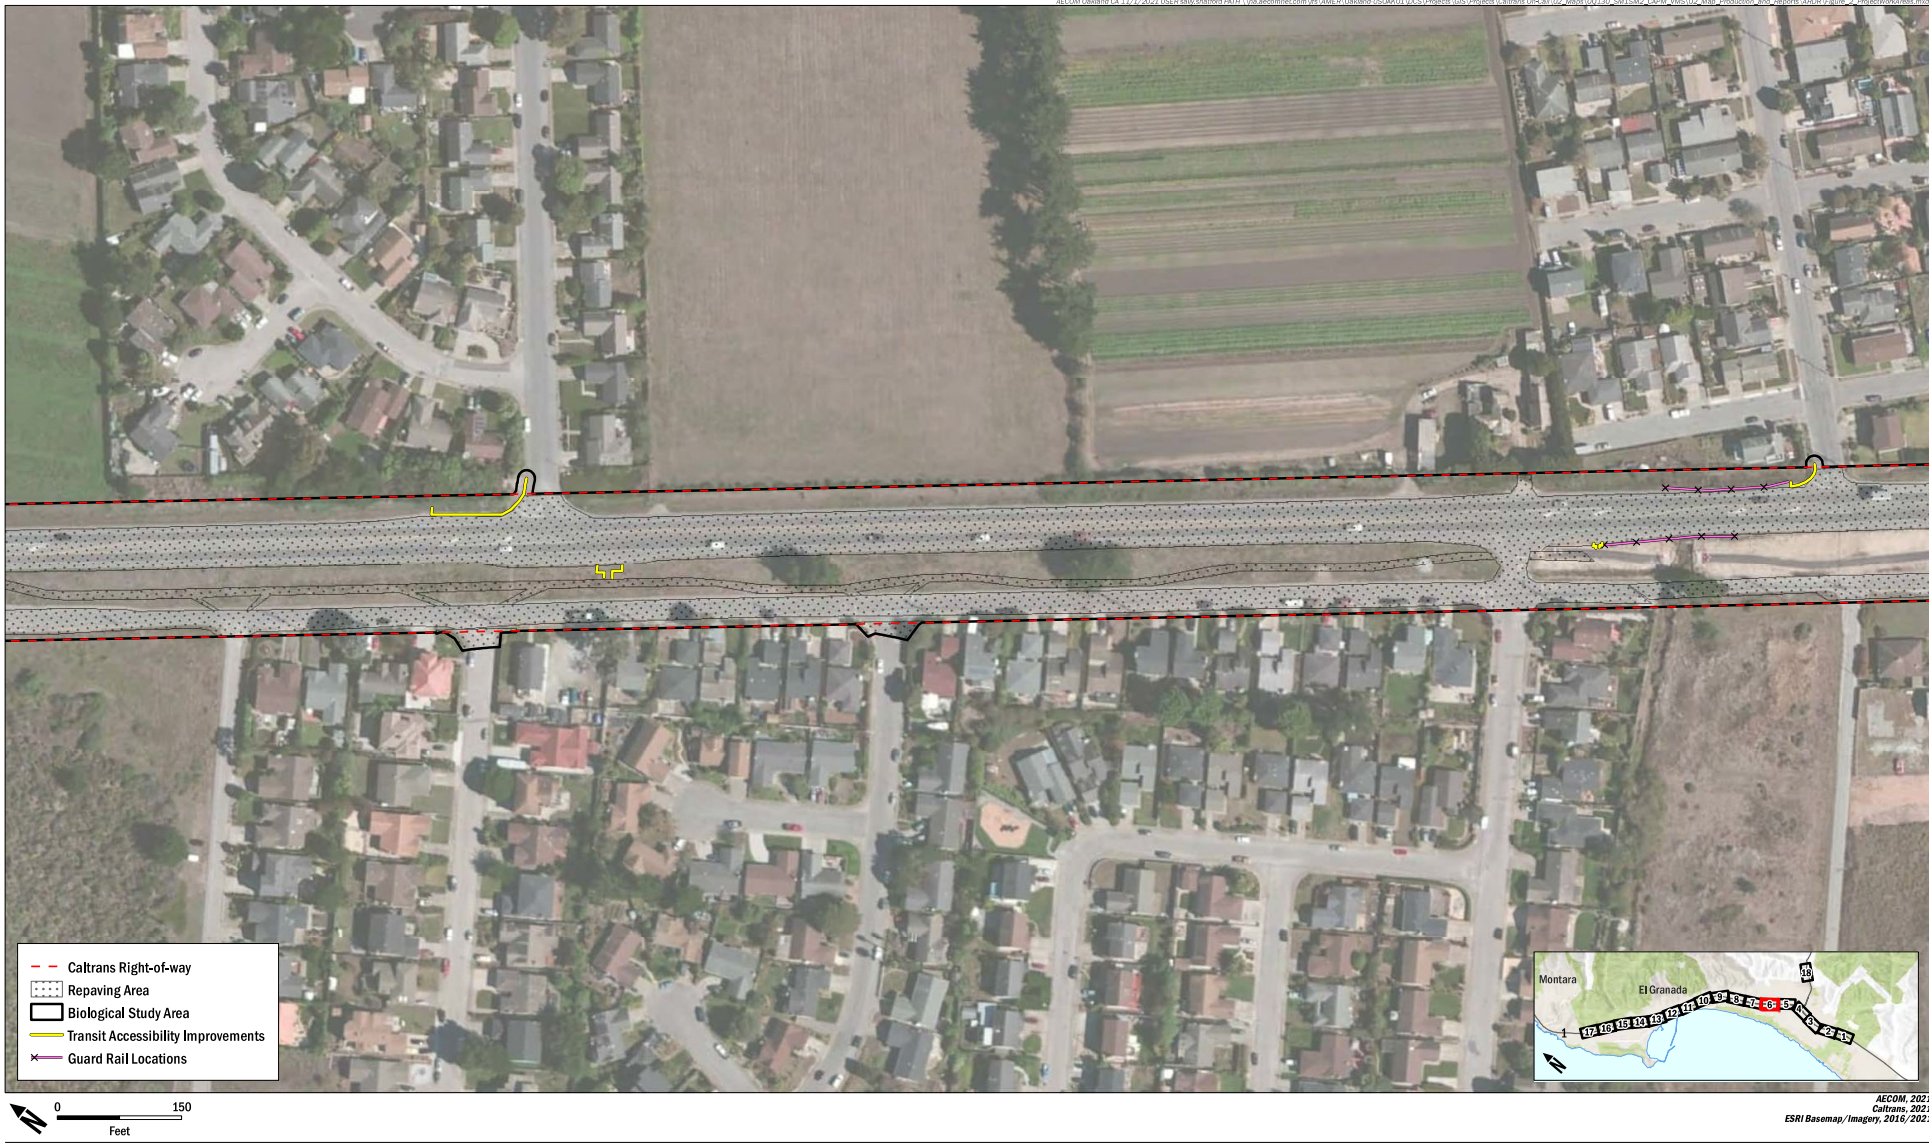
**FIGURE 2**  
Project Work Areas in the  
Biological Study Area  
Page 1 of 18

- - - Caltrans Right-of-way
- Repaving Area
- Biological Study Area
- Drainage Facility, Discovered in Field
- VMS & MVP
- Transit Accessibility Improvements
- x Guard Rail Locations

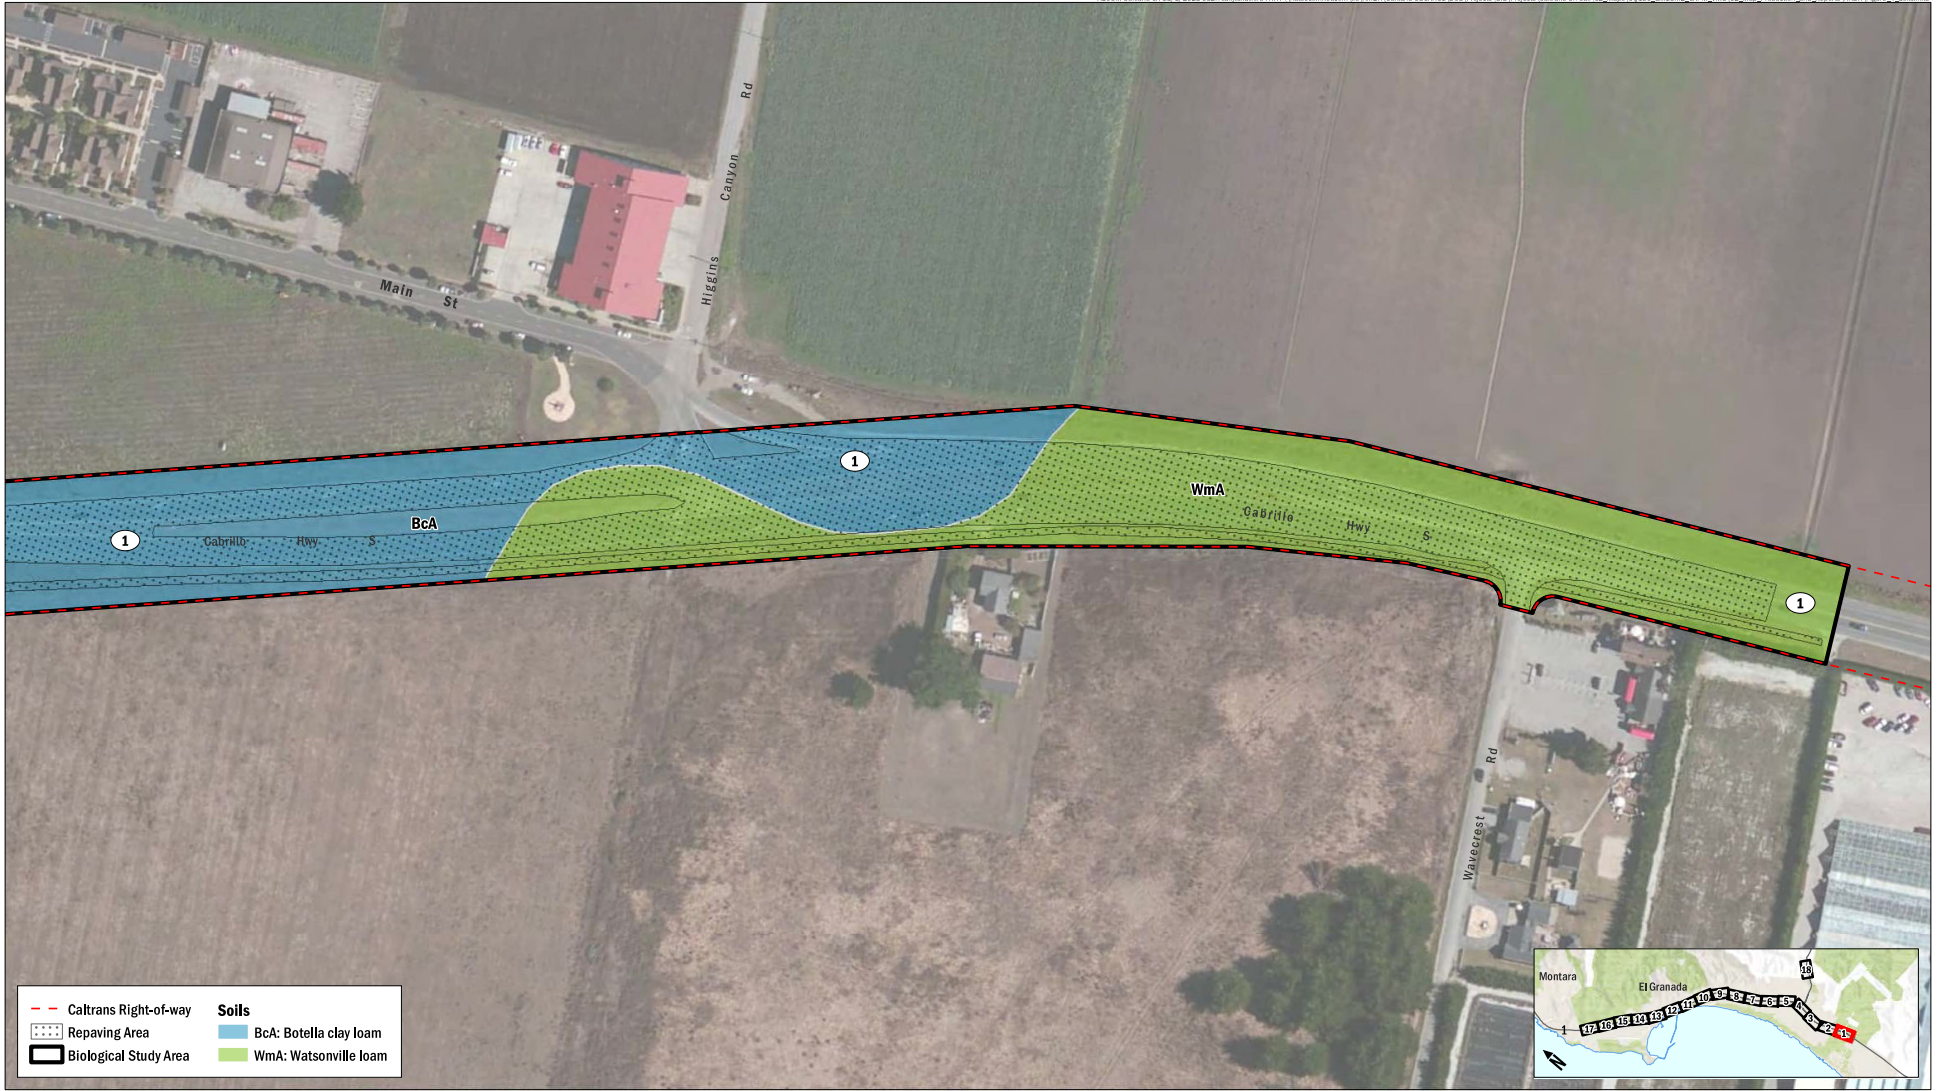
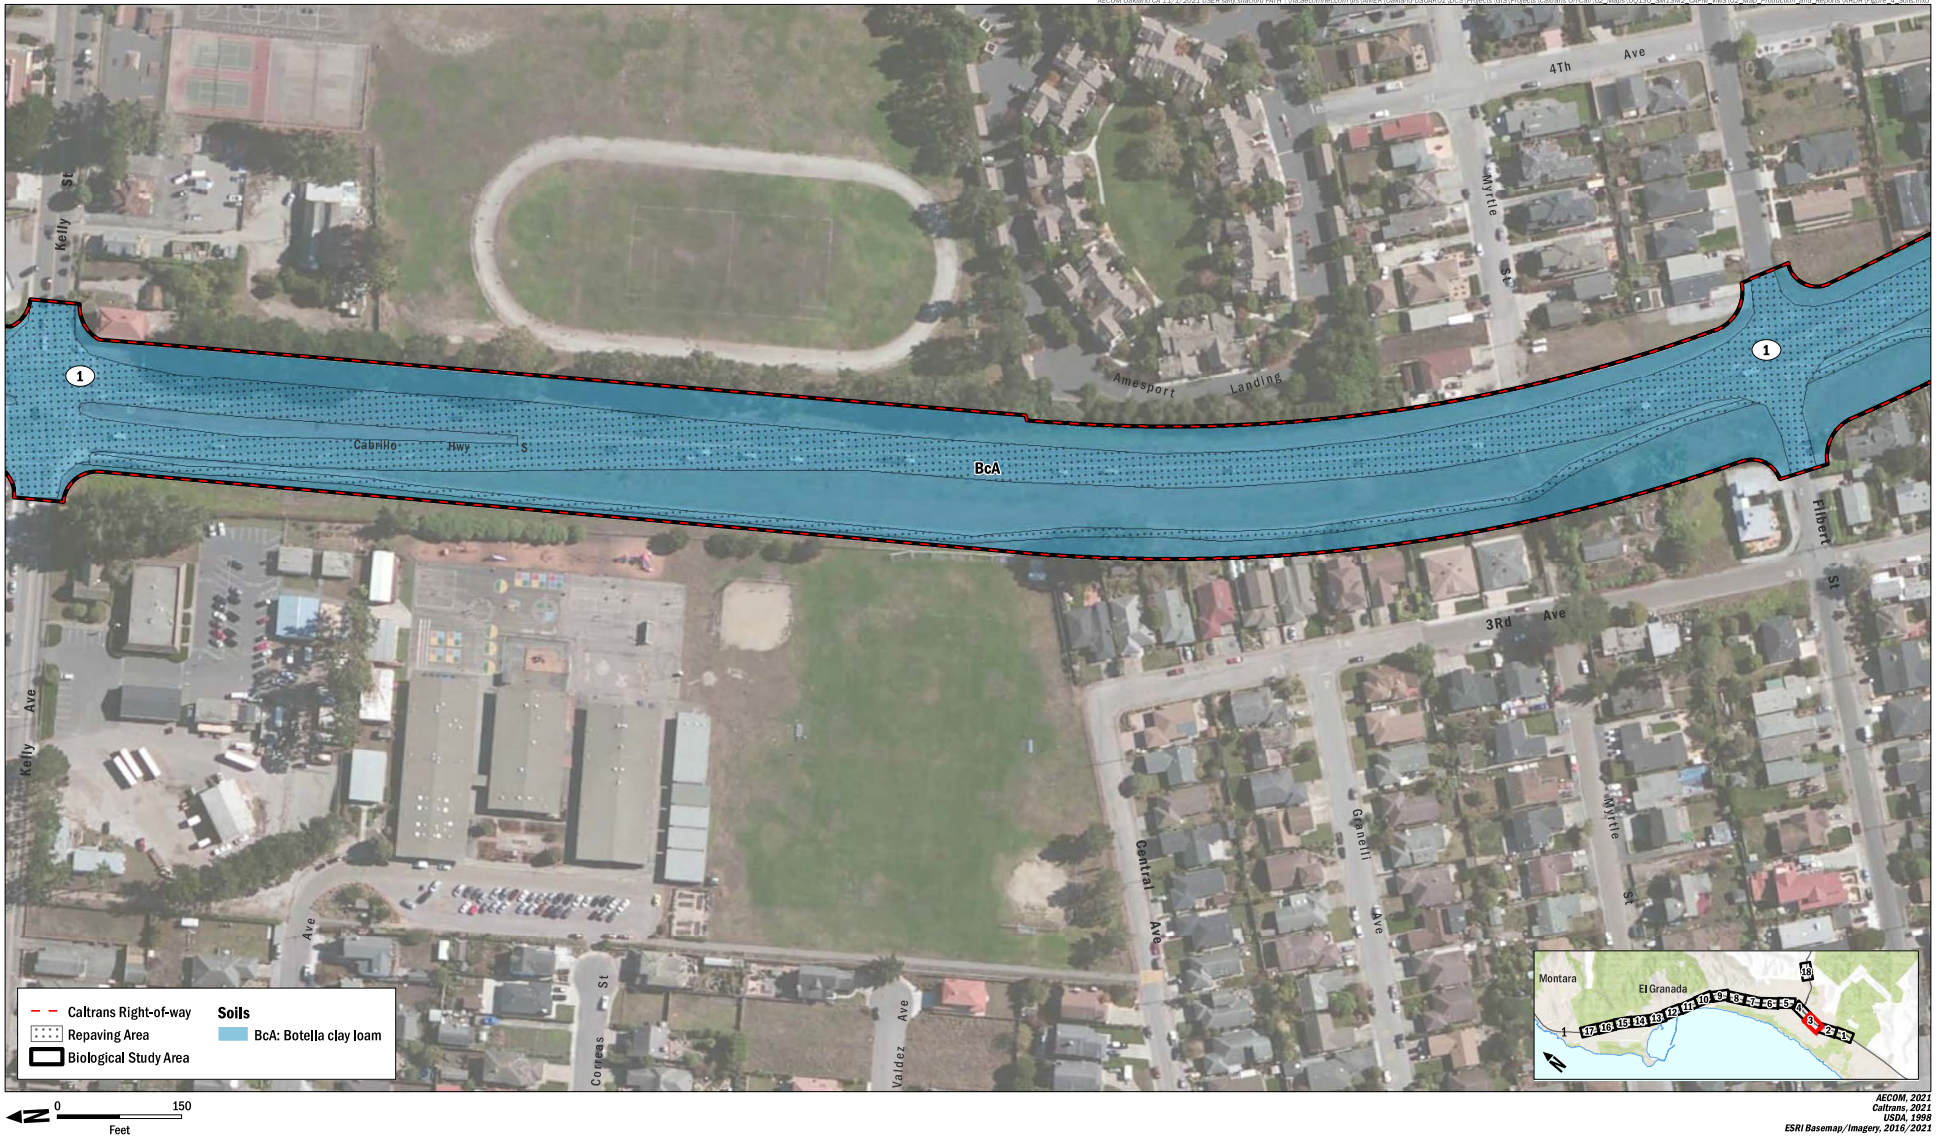
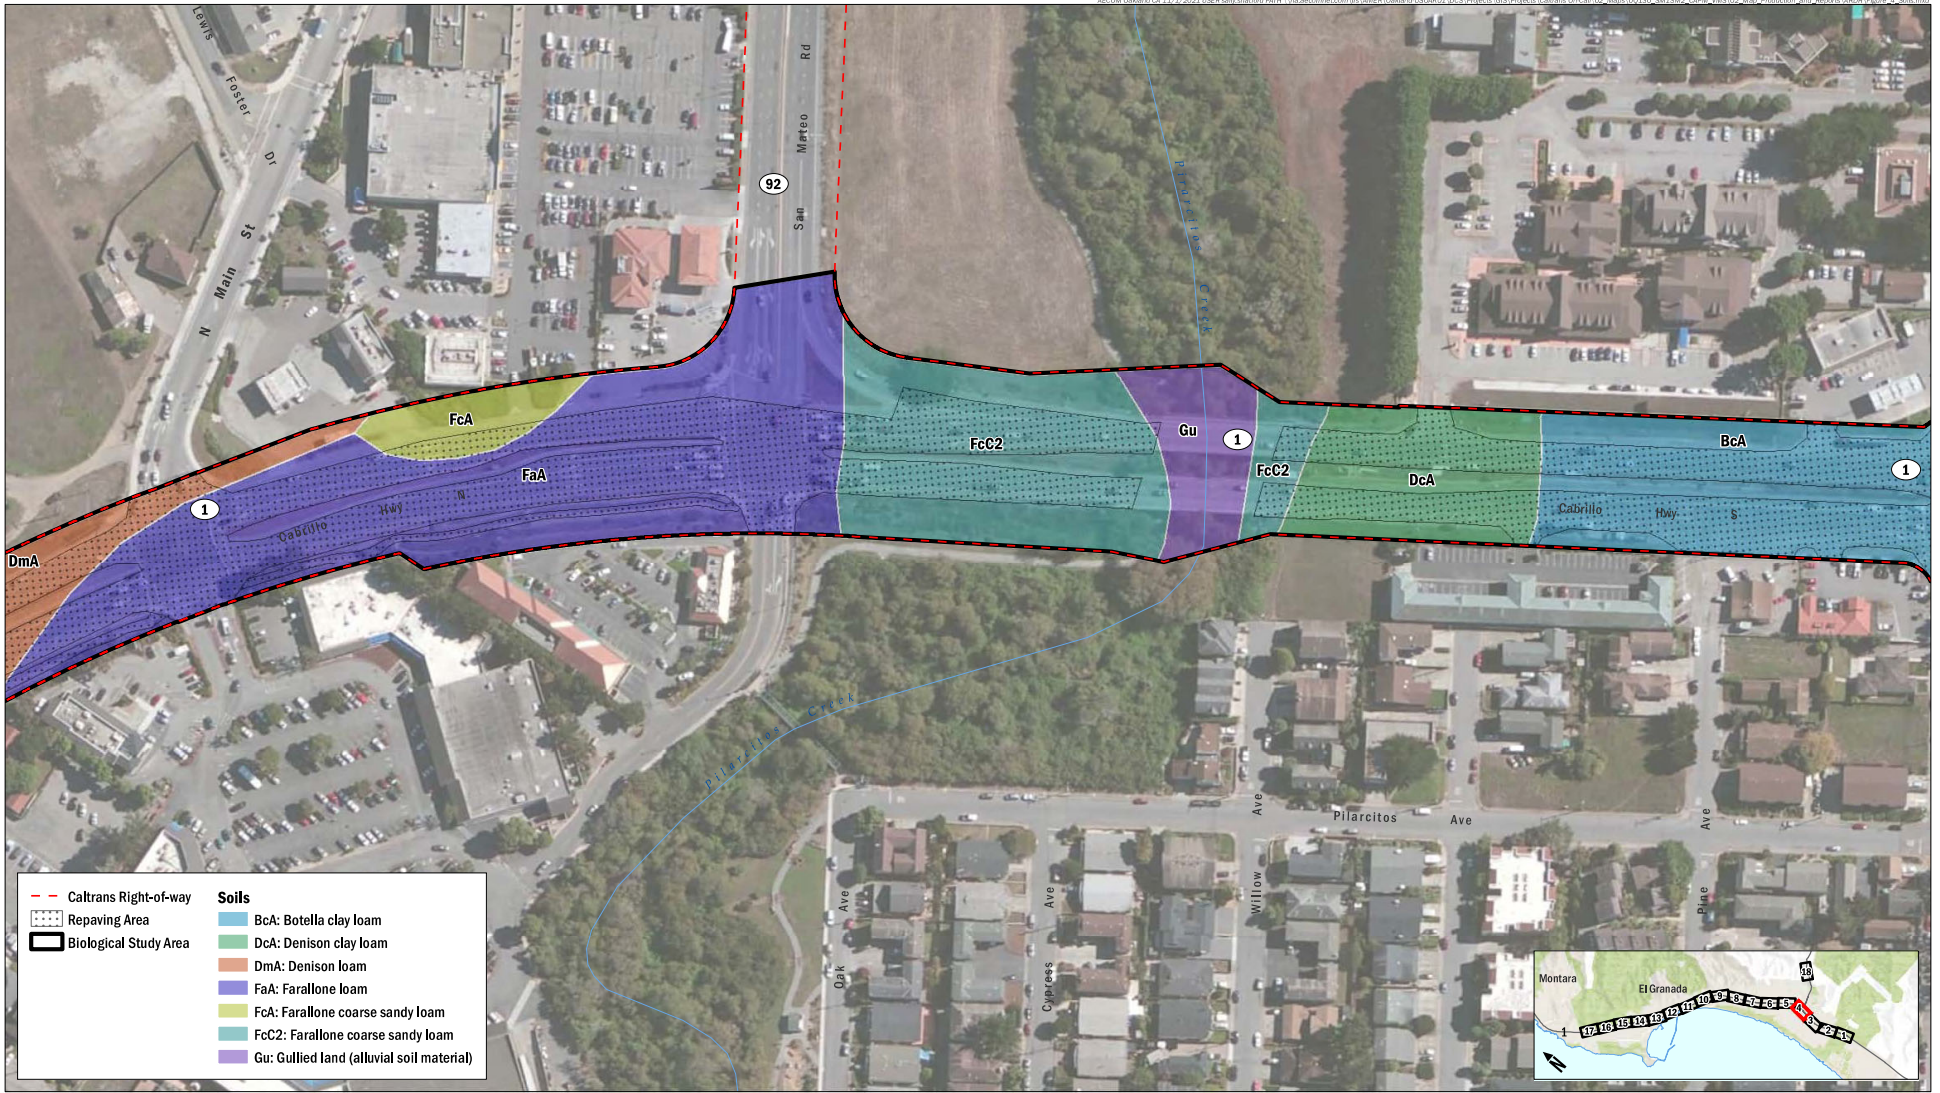
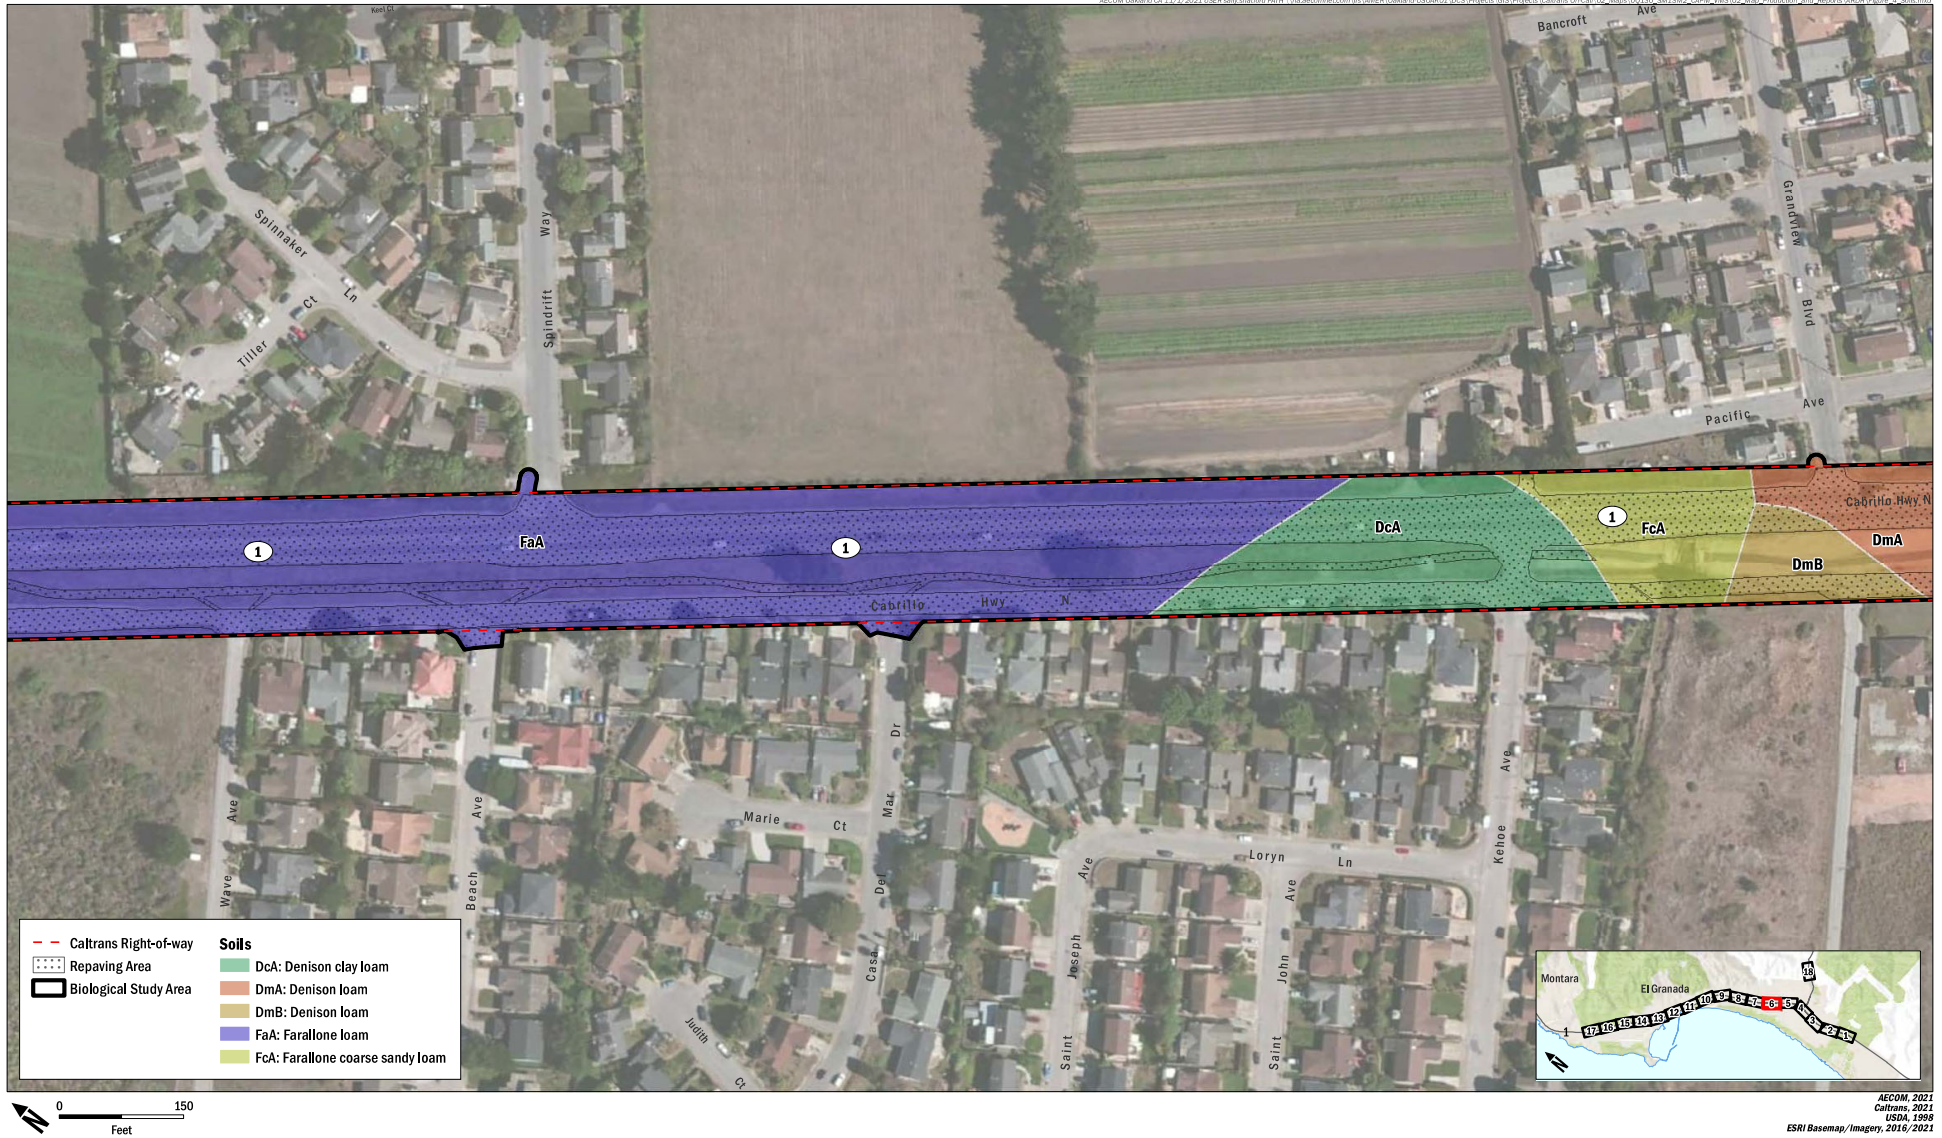
**FIGURE 4**  
 Soils in the Biological Study Area  
 Page 1 of 18

Caltrans Right-of-way	<b>Soils</b>	
	Repaving Area		FaA: Farallone loam
	Biological Study Area		FcA: Farallone coarse sandy loam
			Gu: Gullied land (alluvial soil material)

Caltrans Right-of-way	<b>Soils</b>	
	Repaving Area		DeA: Denison coarse sandy loam
	Biological Study Area		DmB: Denison loam
			FcB: Farallone coarse sandy loam
			FsB: Farallone coarse sandy loam
			Gu: Gullied land (alluvial soil material)
			WmC2: Watsonville loam
