# State Route 1 Multi-Asset Roadway Rehabilitation Project

## **Aquatic Resource Delineation**

SAN MATEO COUNTY, CALIFORNIA

04-01-SM-PM 27.5/34.8

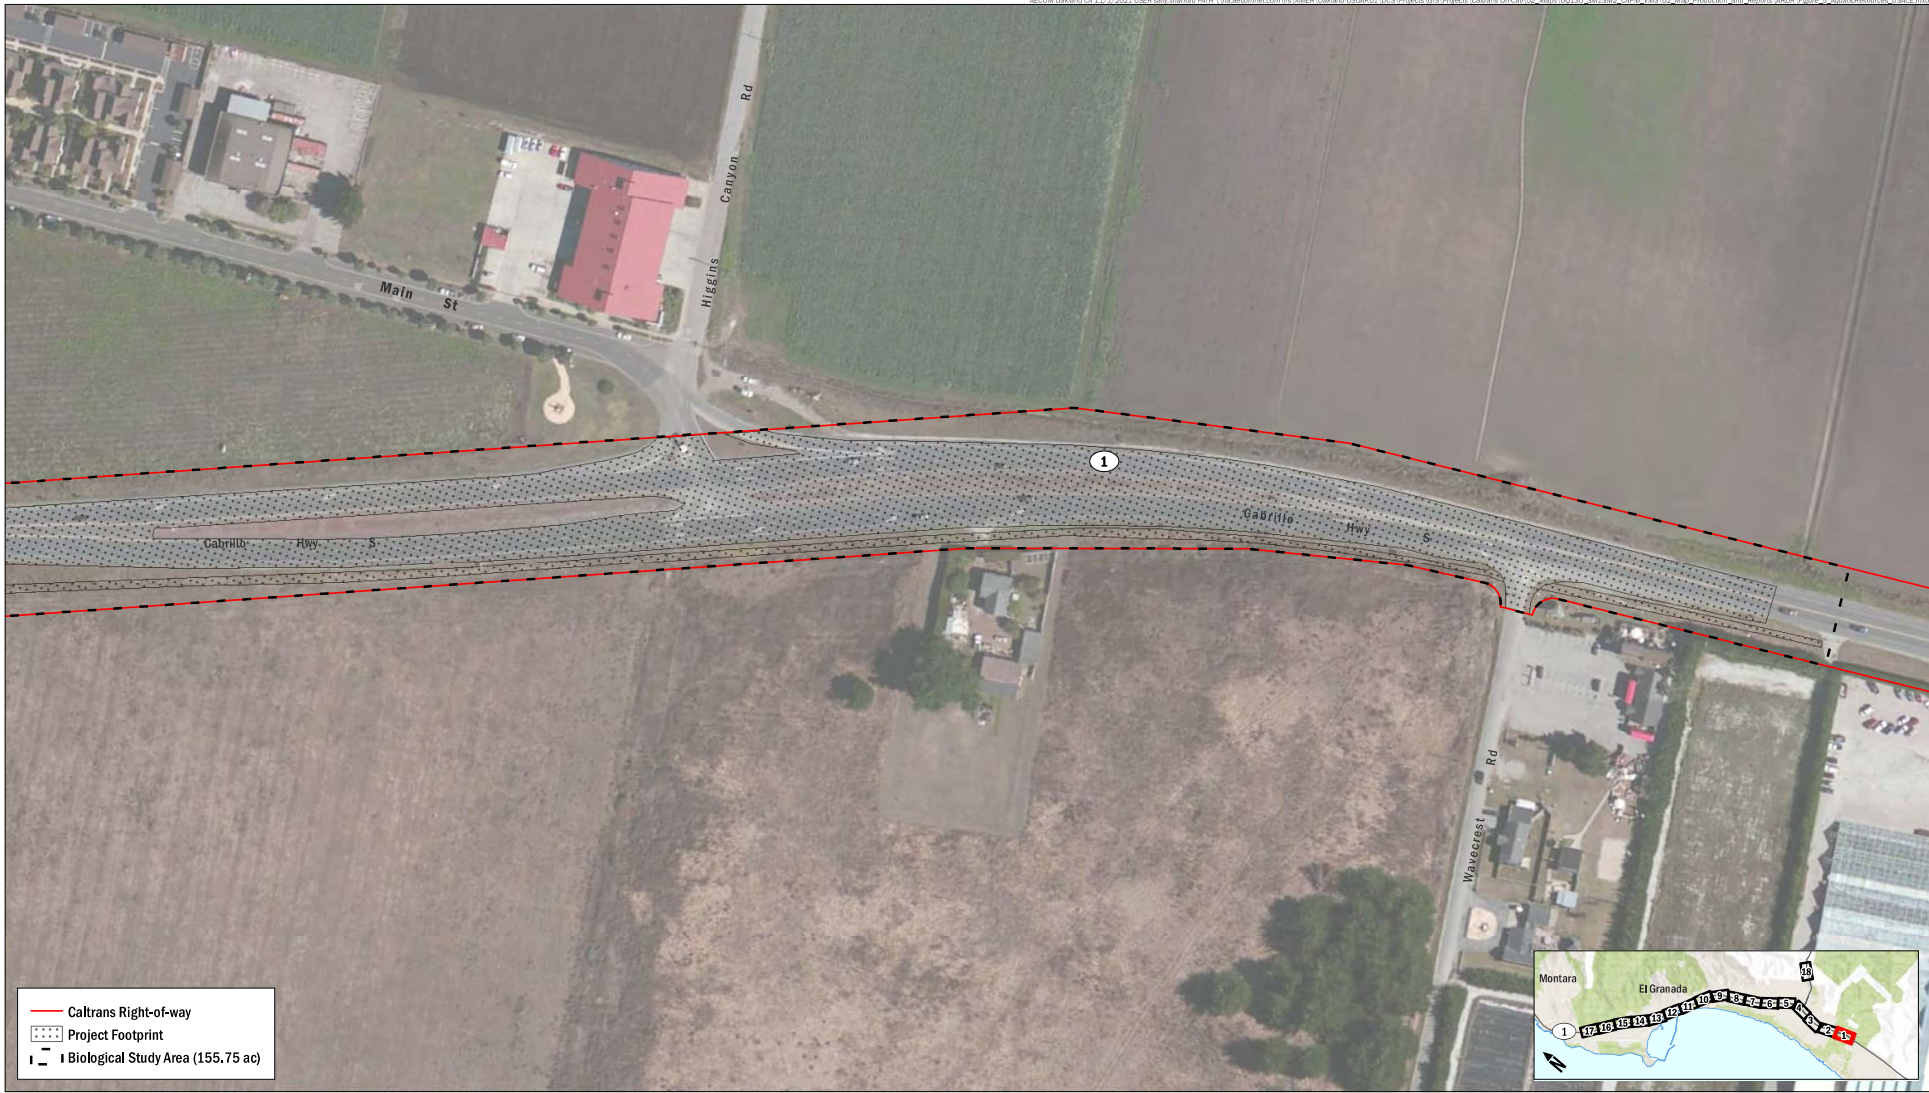
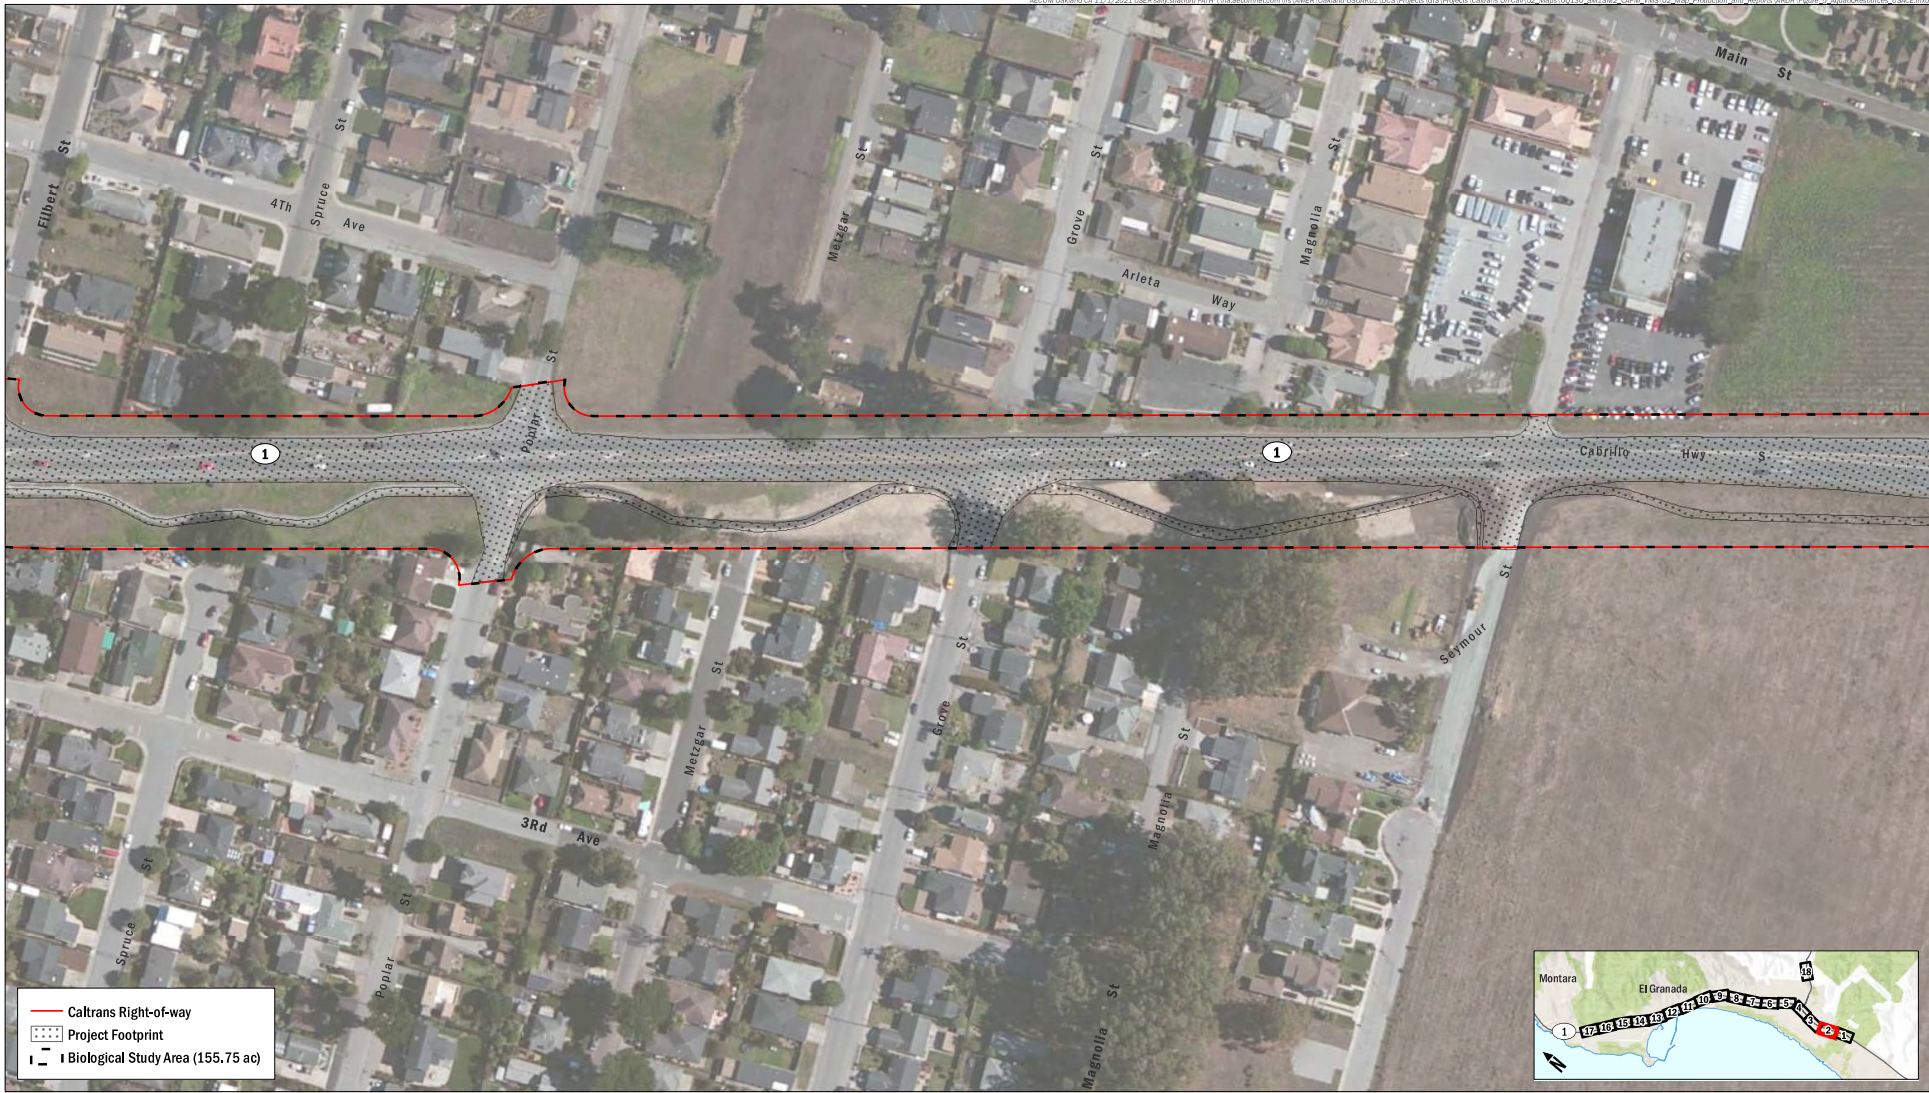
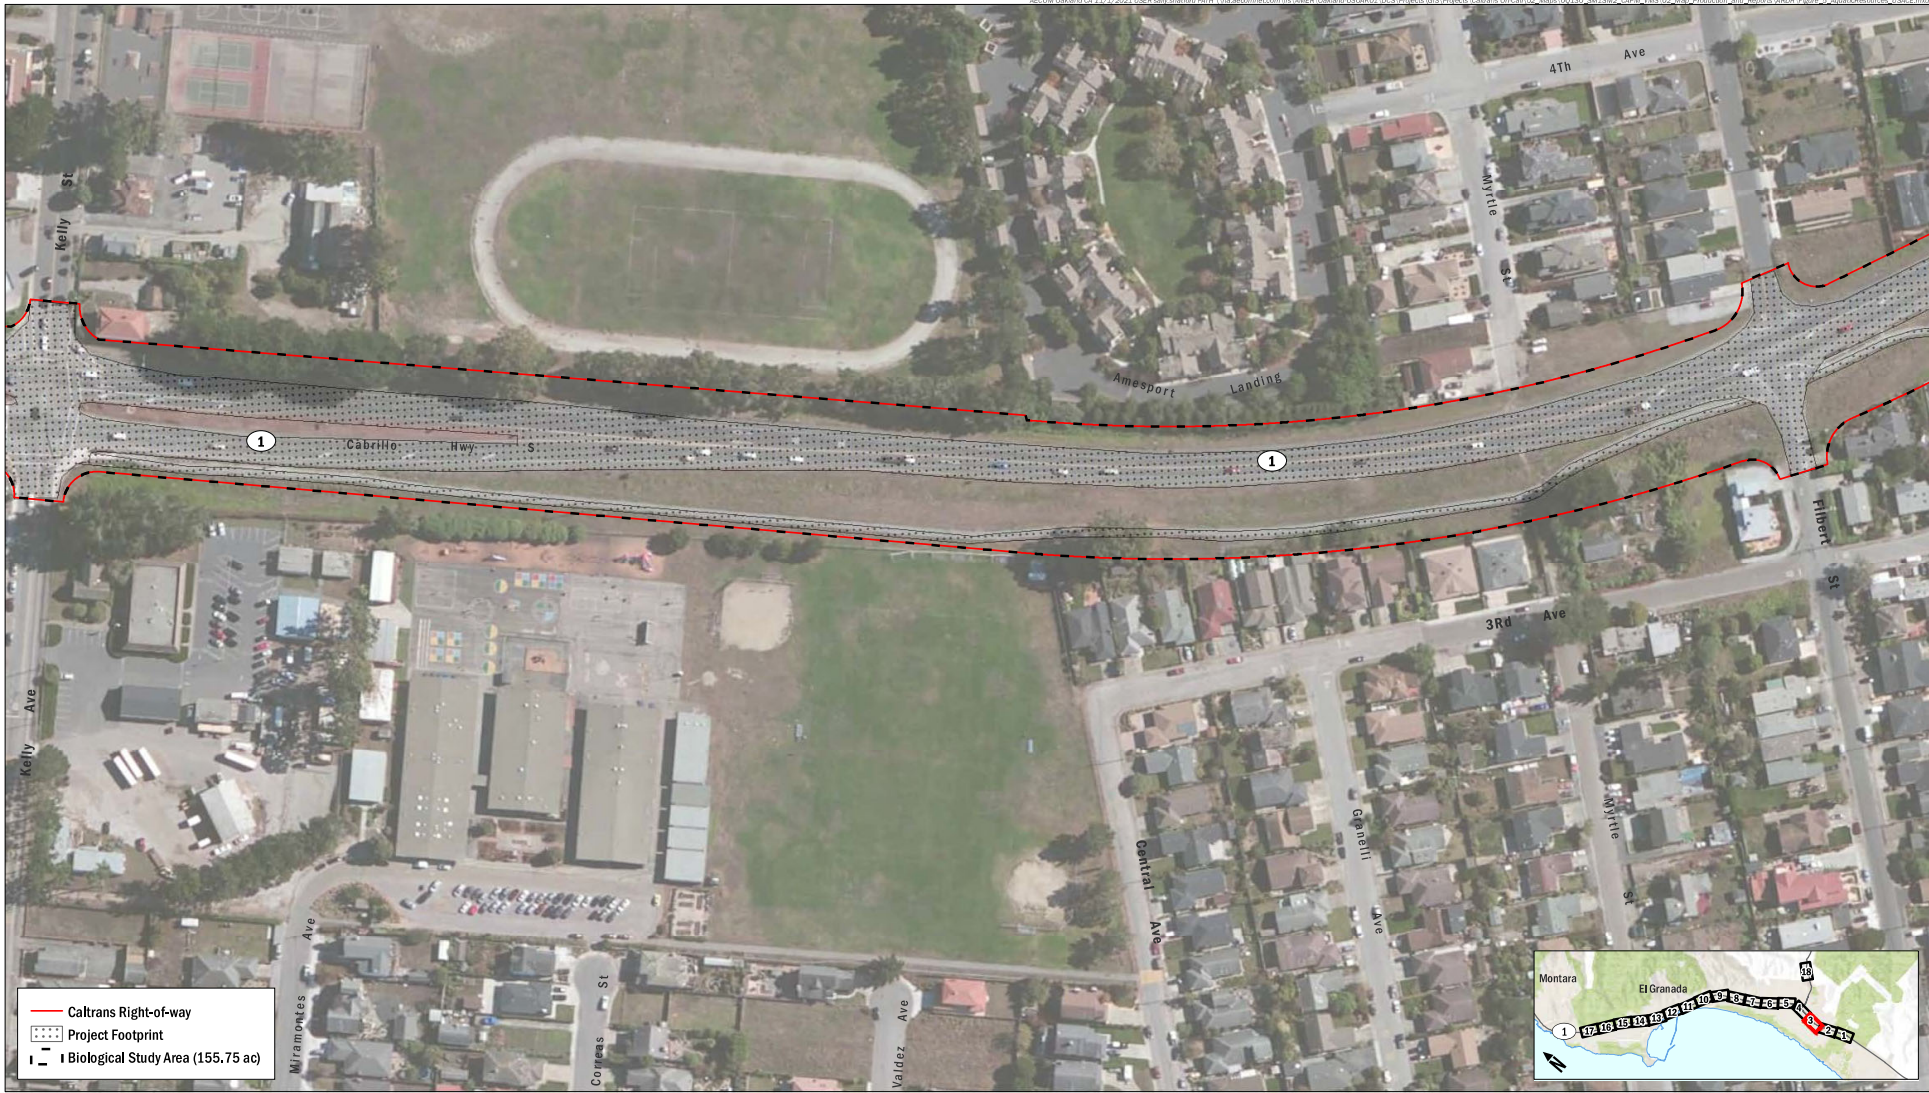
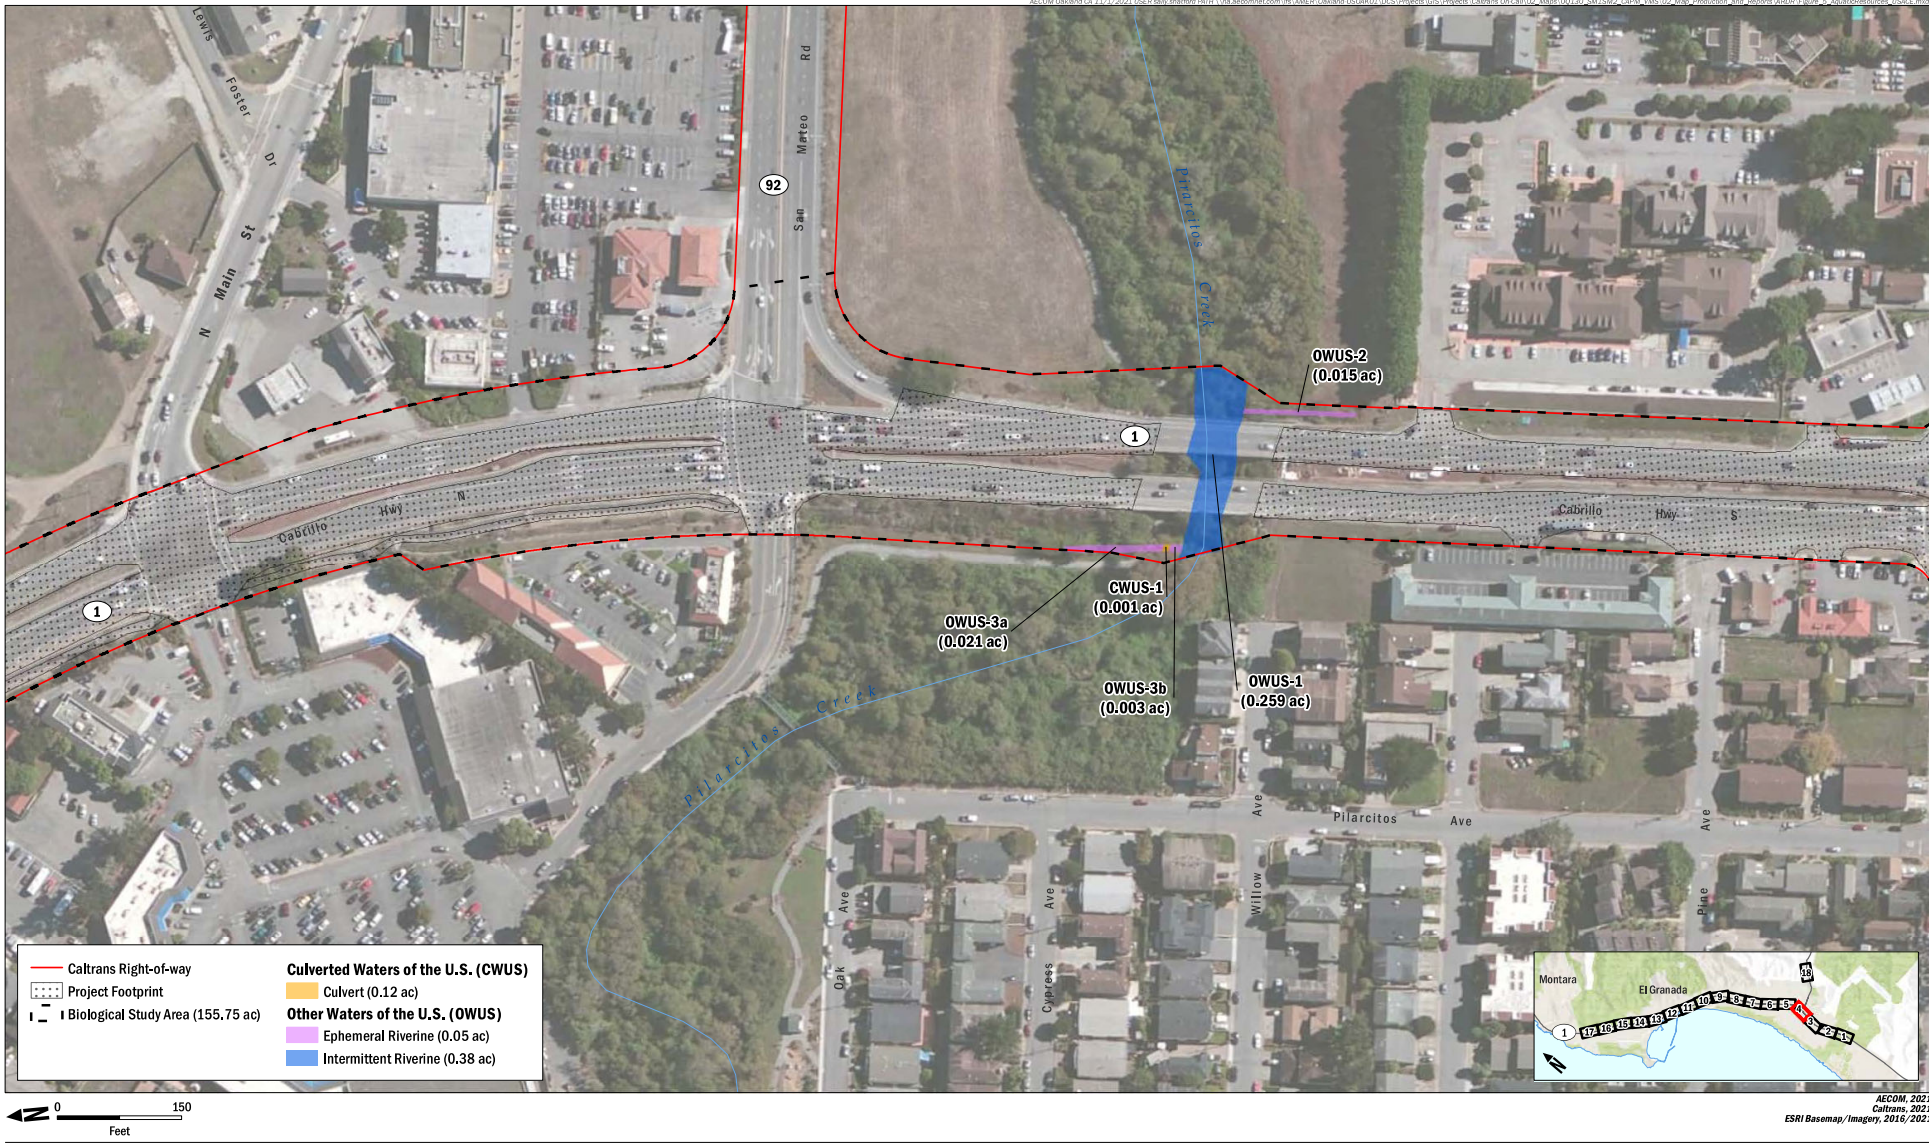
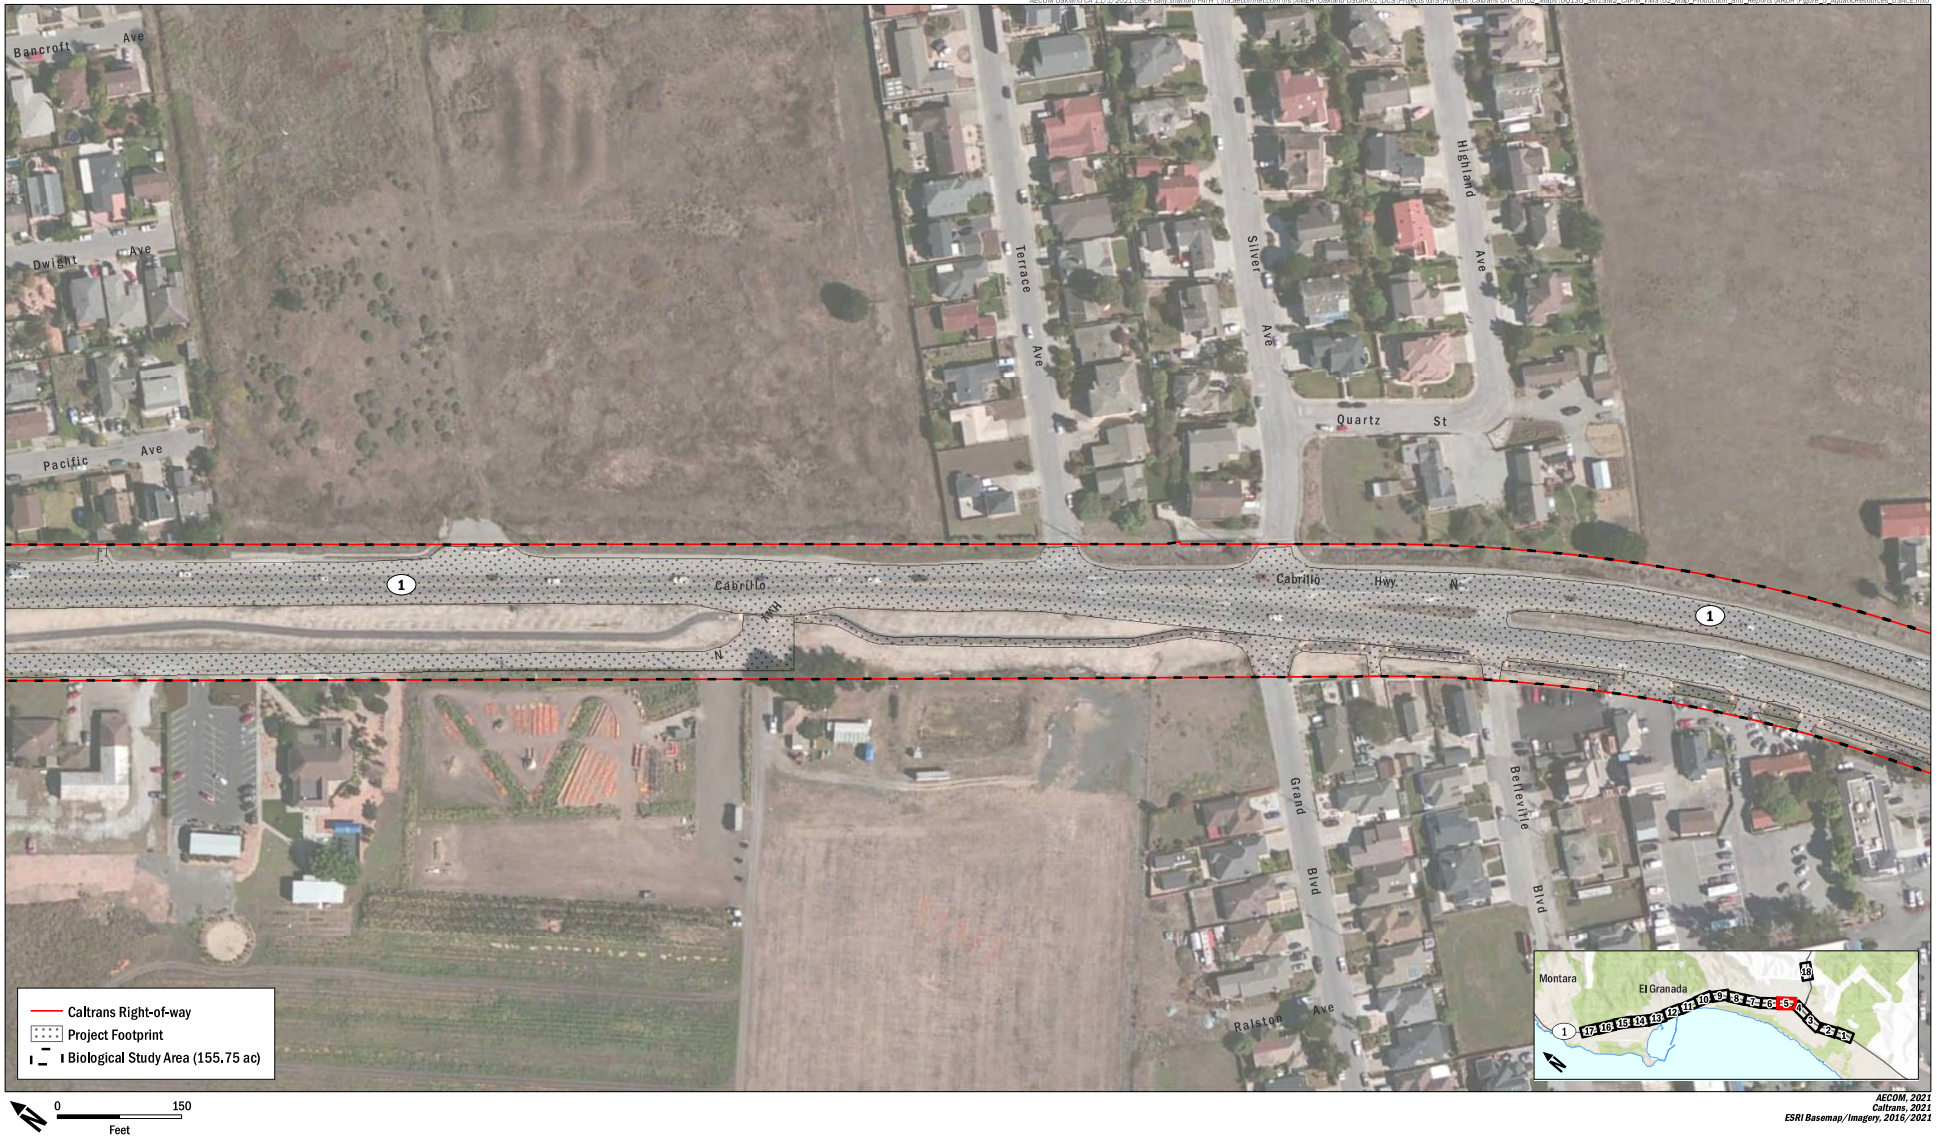
**FIGURE 5**  
Wetlands and Waters of the United States  
Page 1 of 18

- Caltrans Right-of-way
- Project Footprint
- Biological Study Area (155.75 ac)

Table 4 summarizes the area and length of each potential jurisdictional WOTUS delineated in the BSA. Wetland features are identified by the water feature in which they are found, where applicable. All potential WOTUS are mapped in Figure 5.
