# State Route 1 Multi-Asset Roadway Rehabilitation Project

## **Aquatic Resource Delineation**

SAN MATEO COUNTY, CALIFORNIA

04-01-SM-PM 27.5/34.8

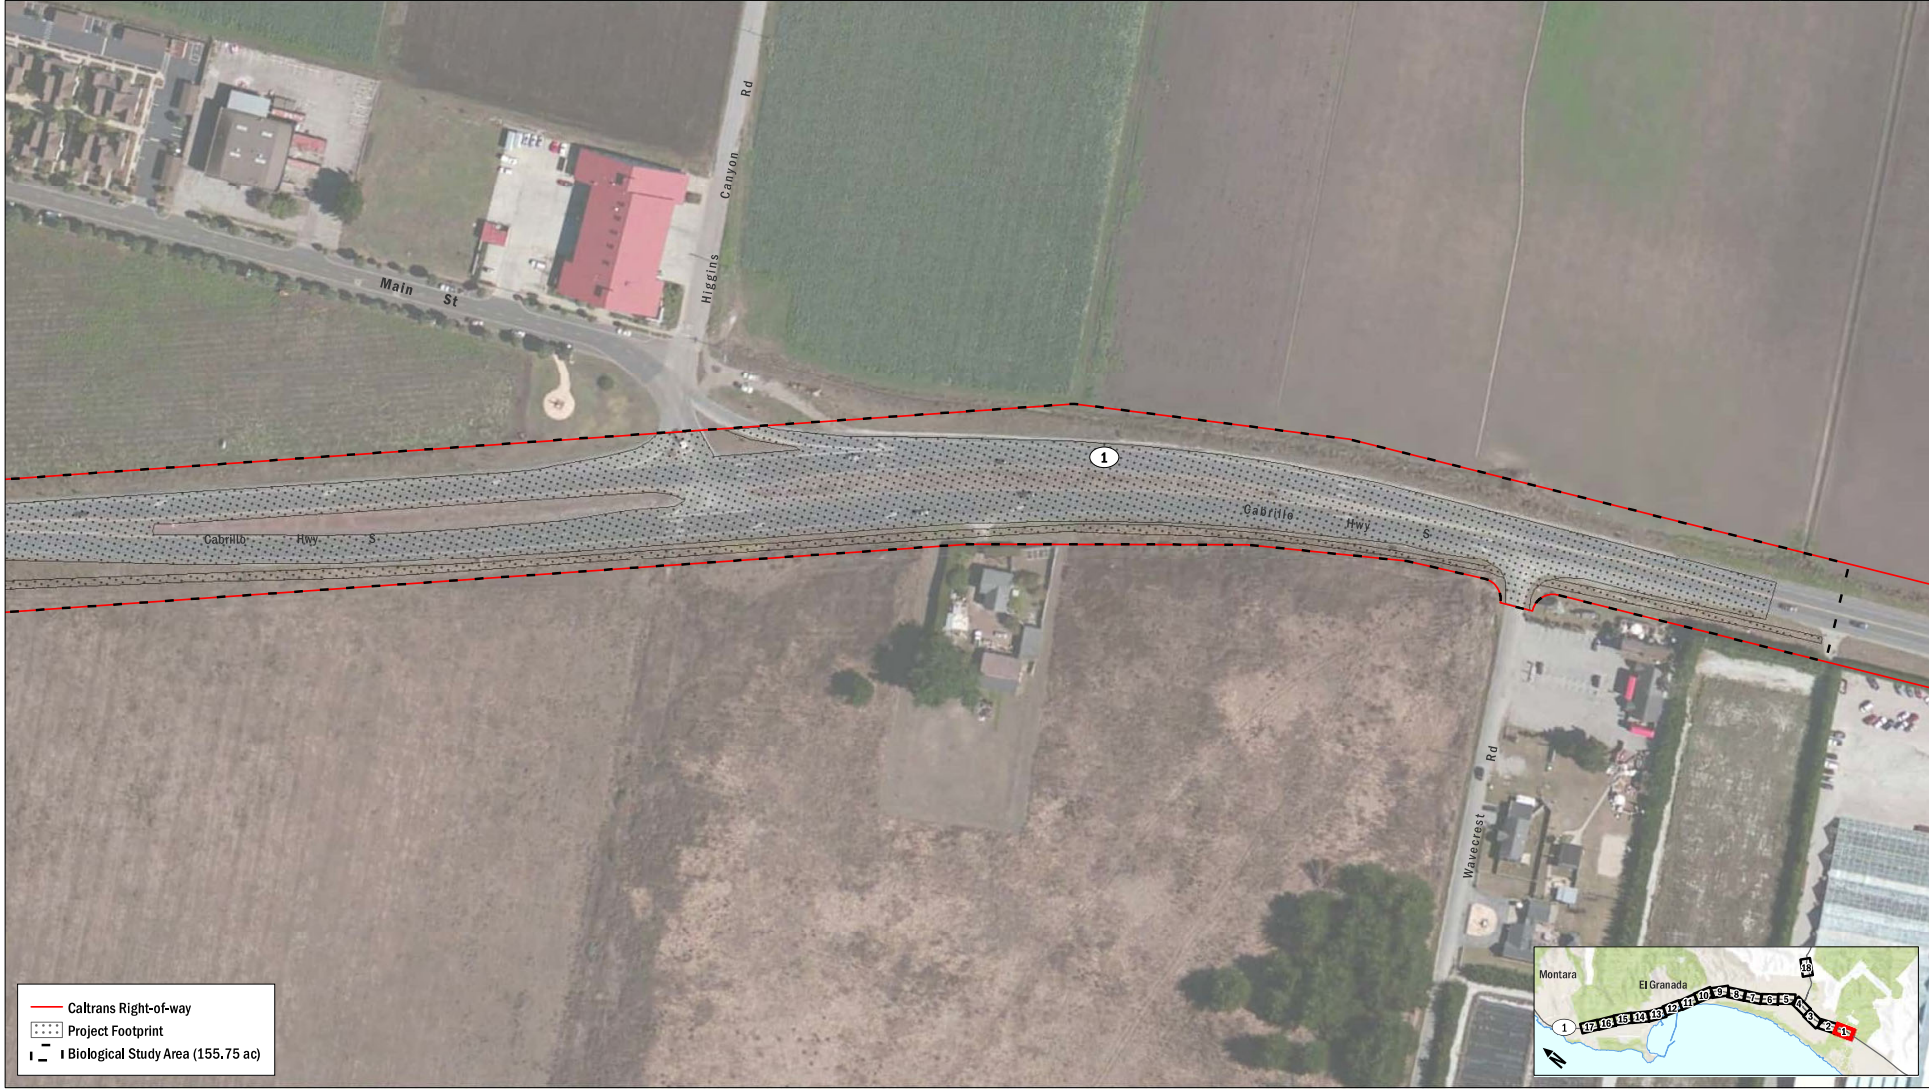
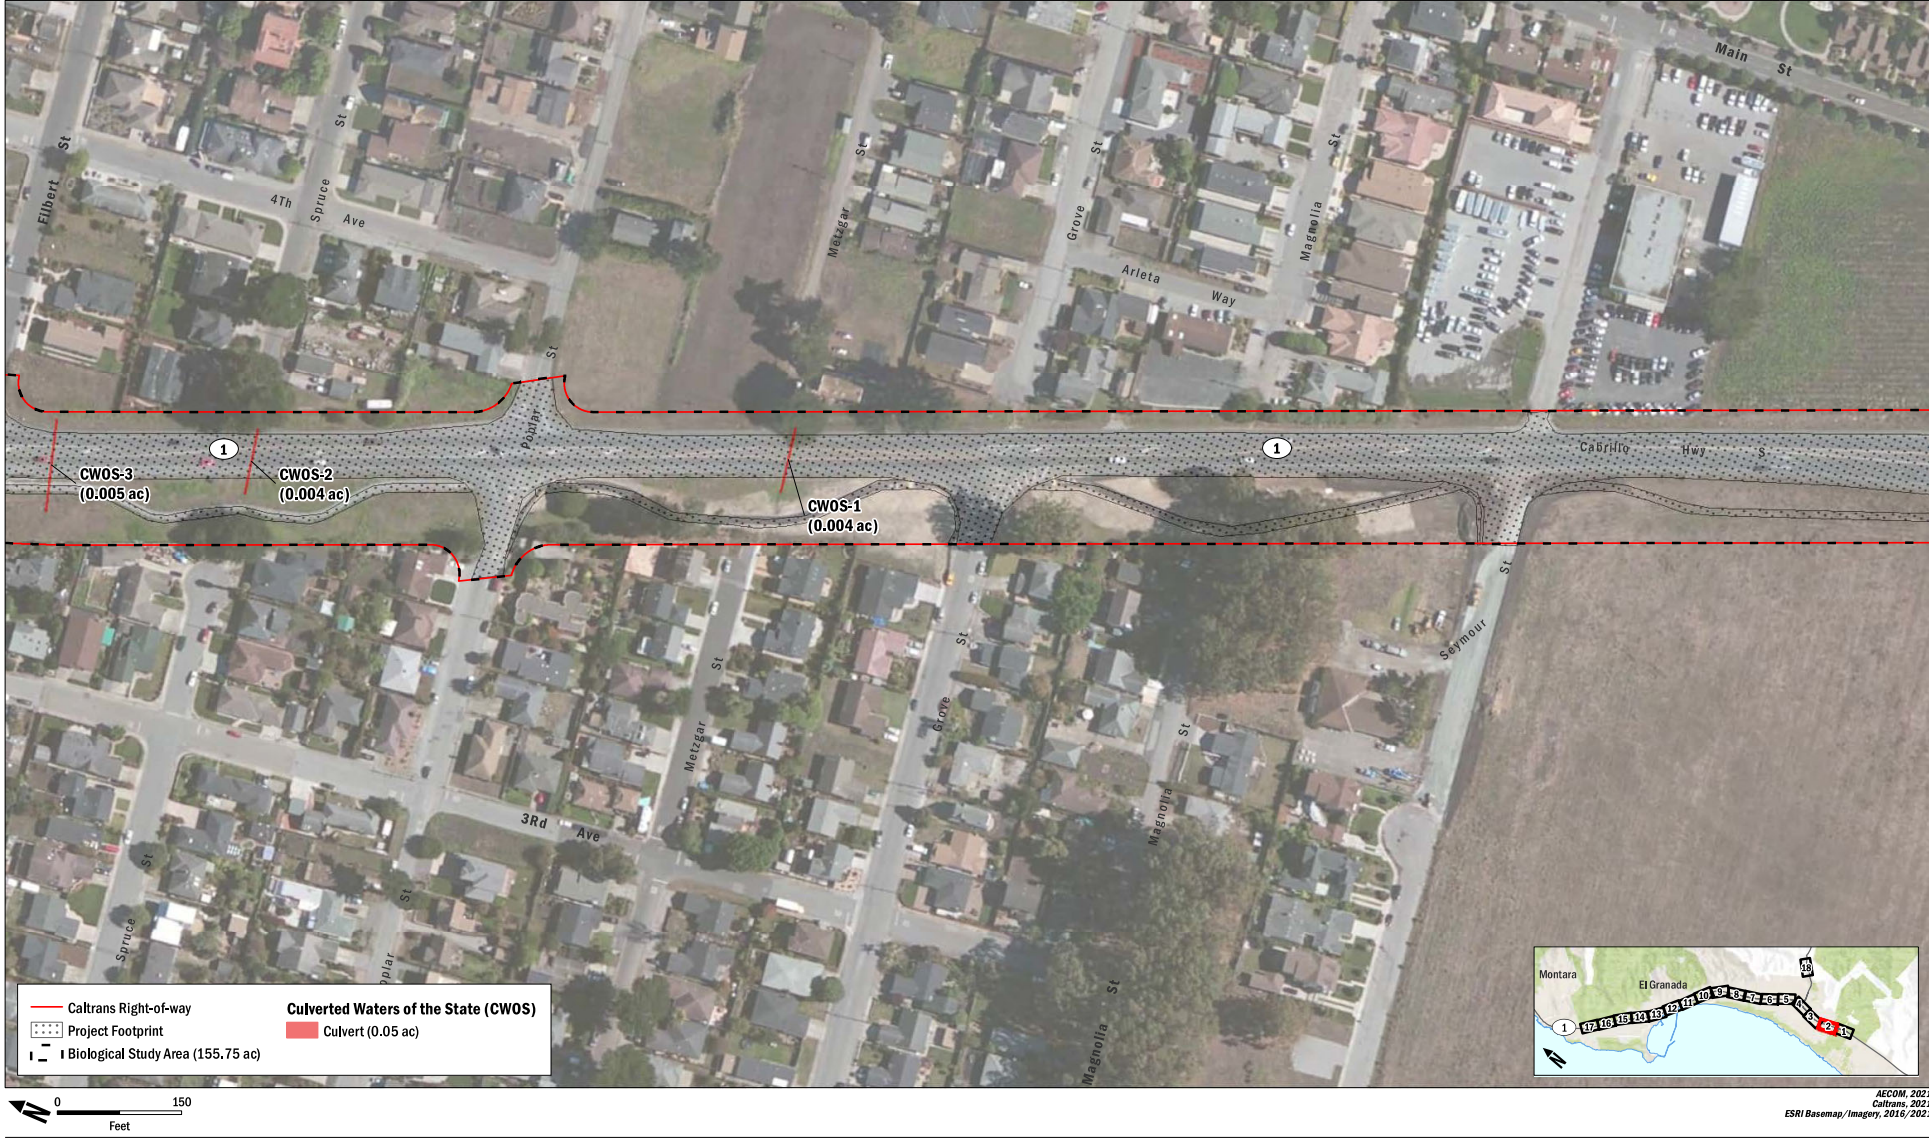
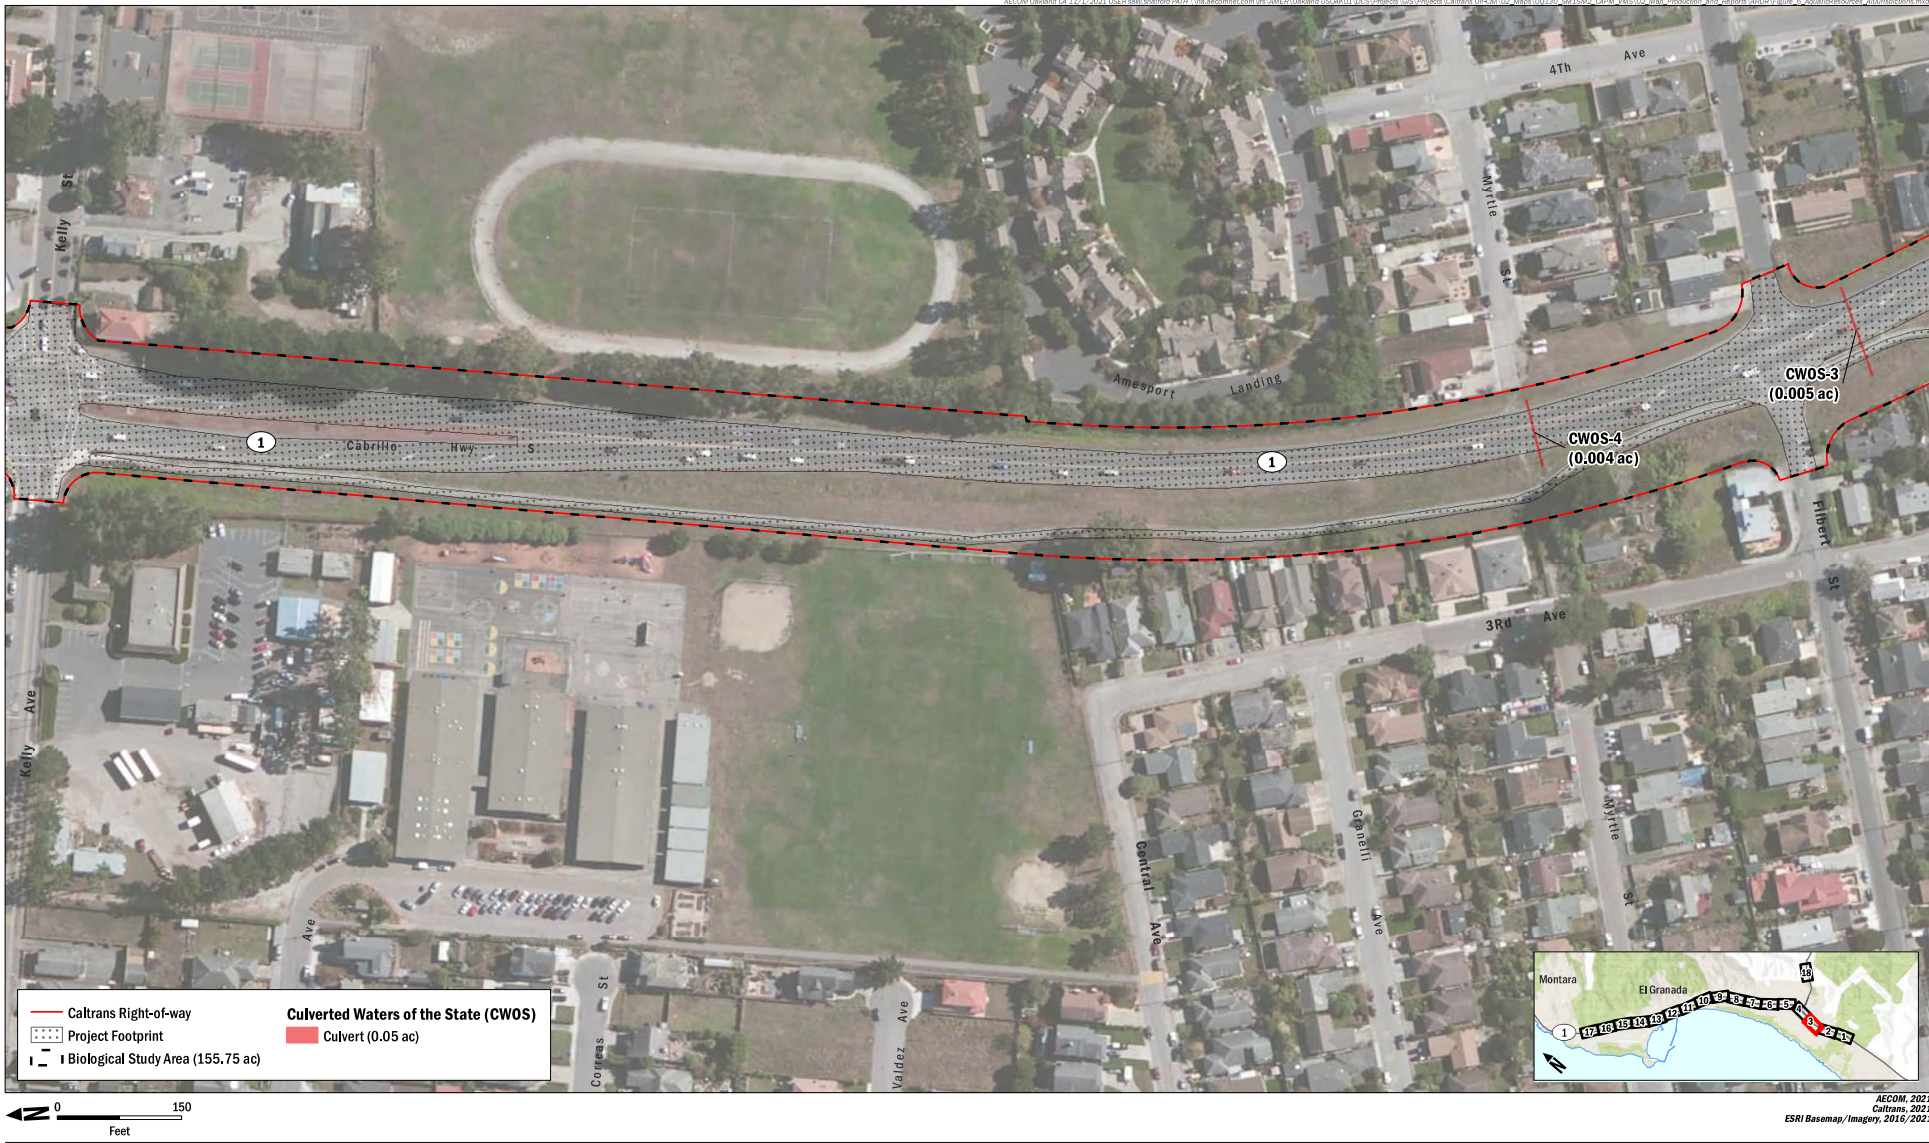
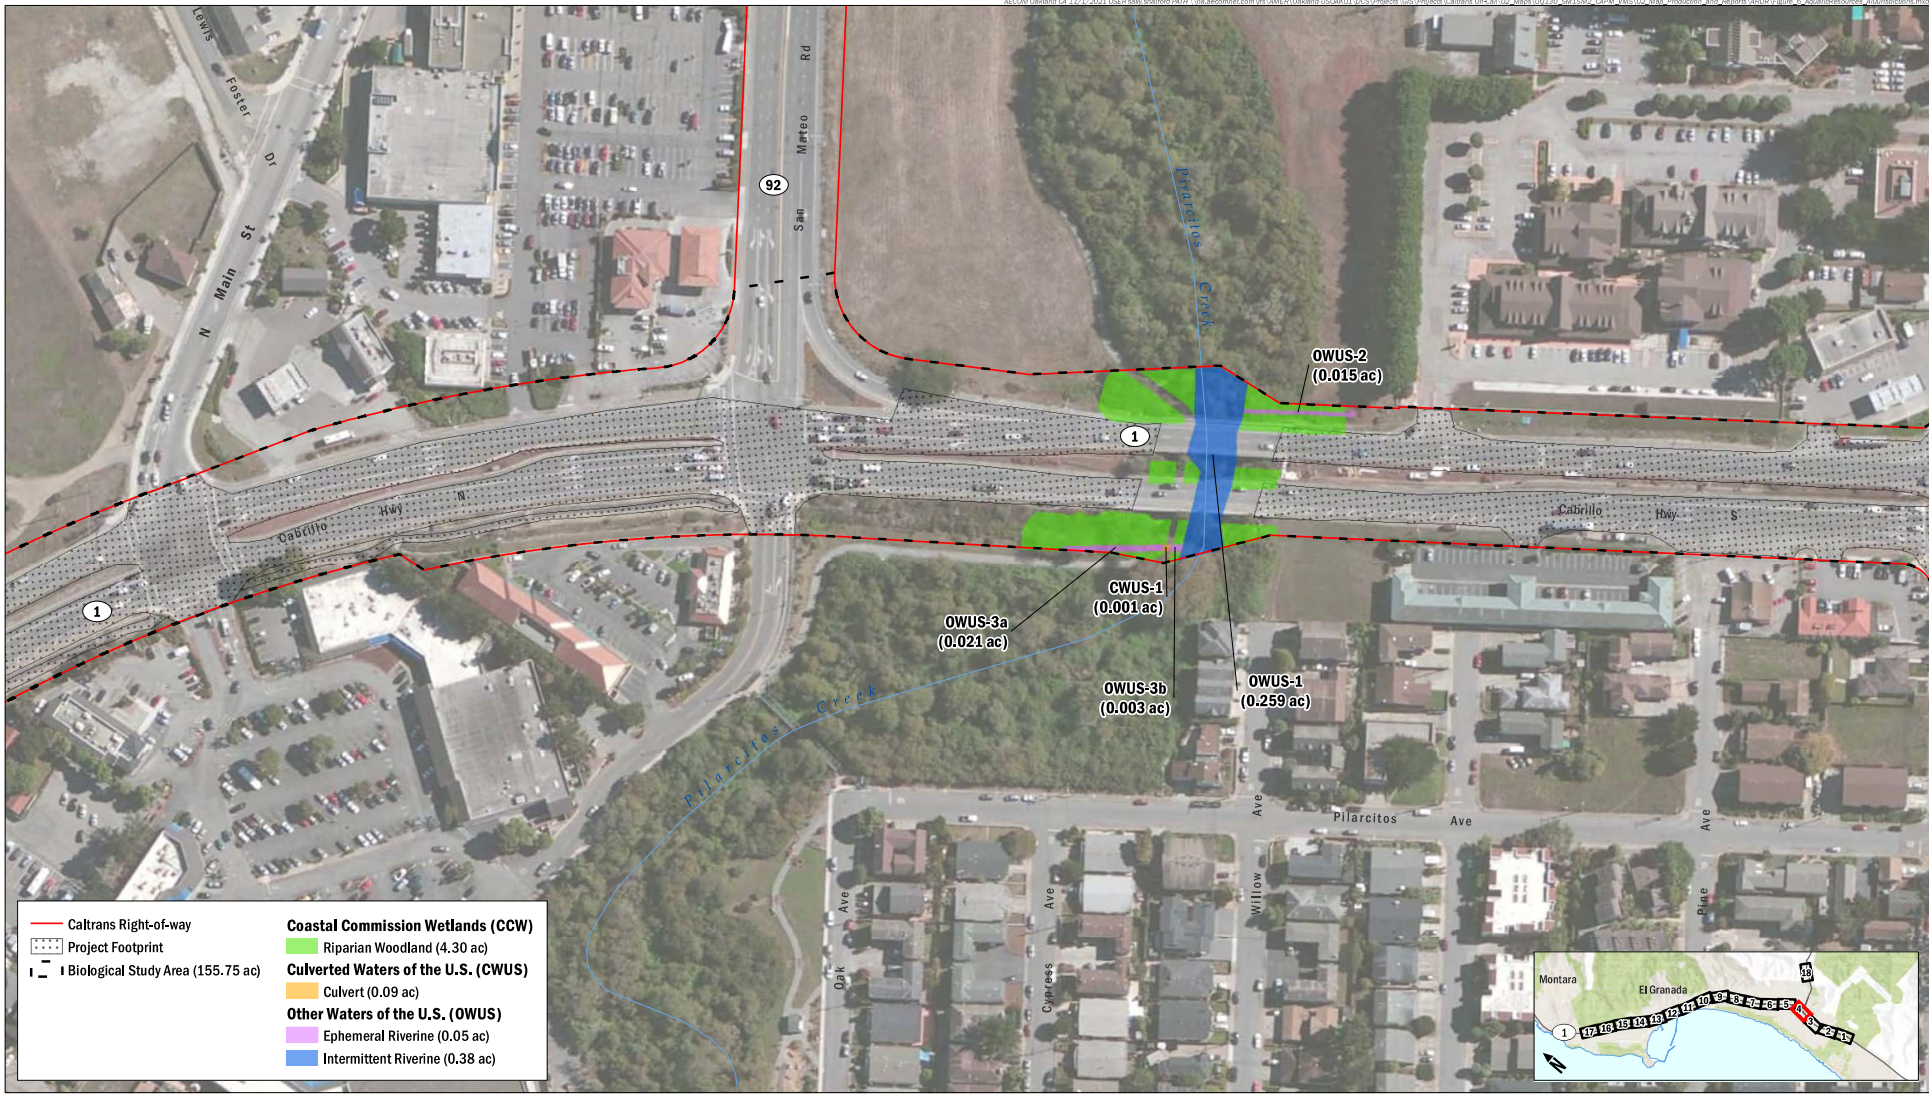
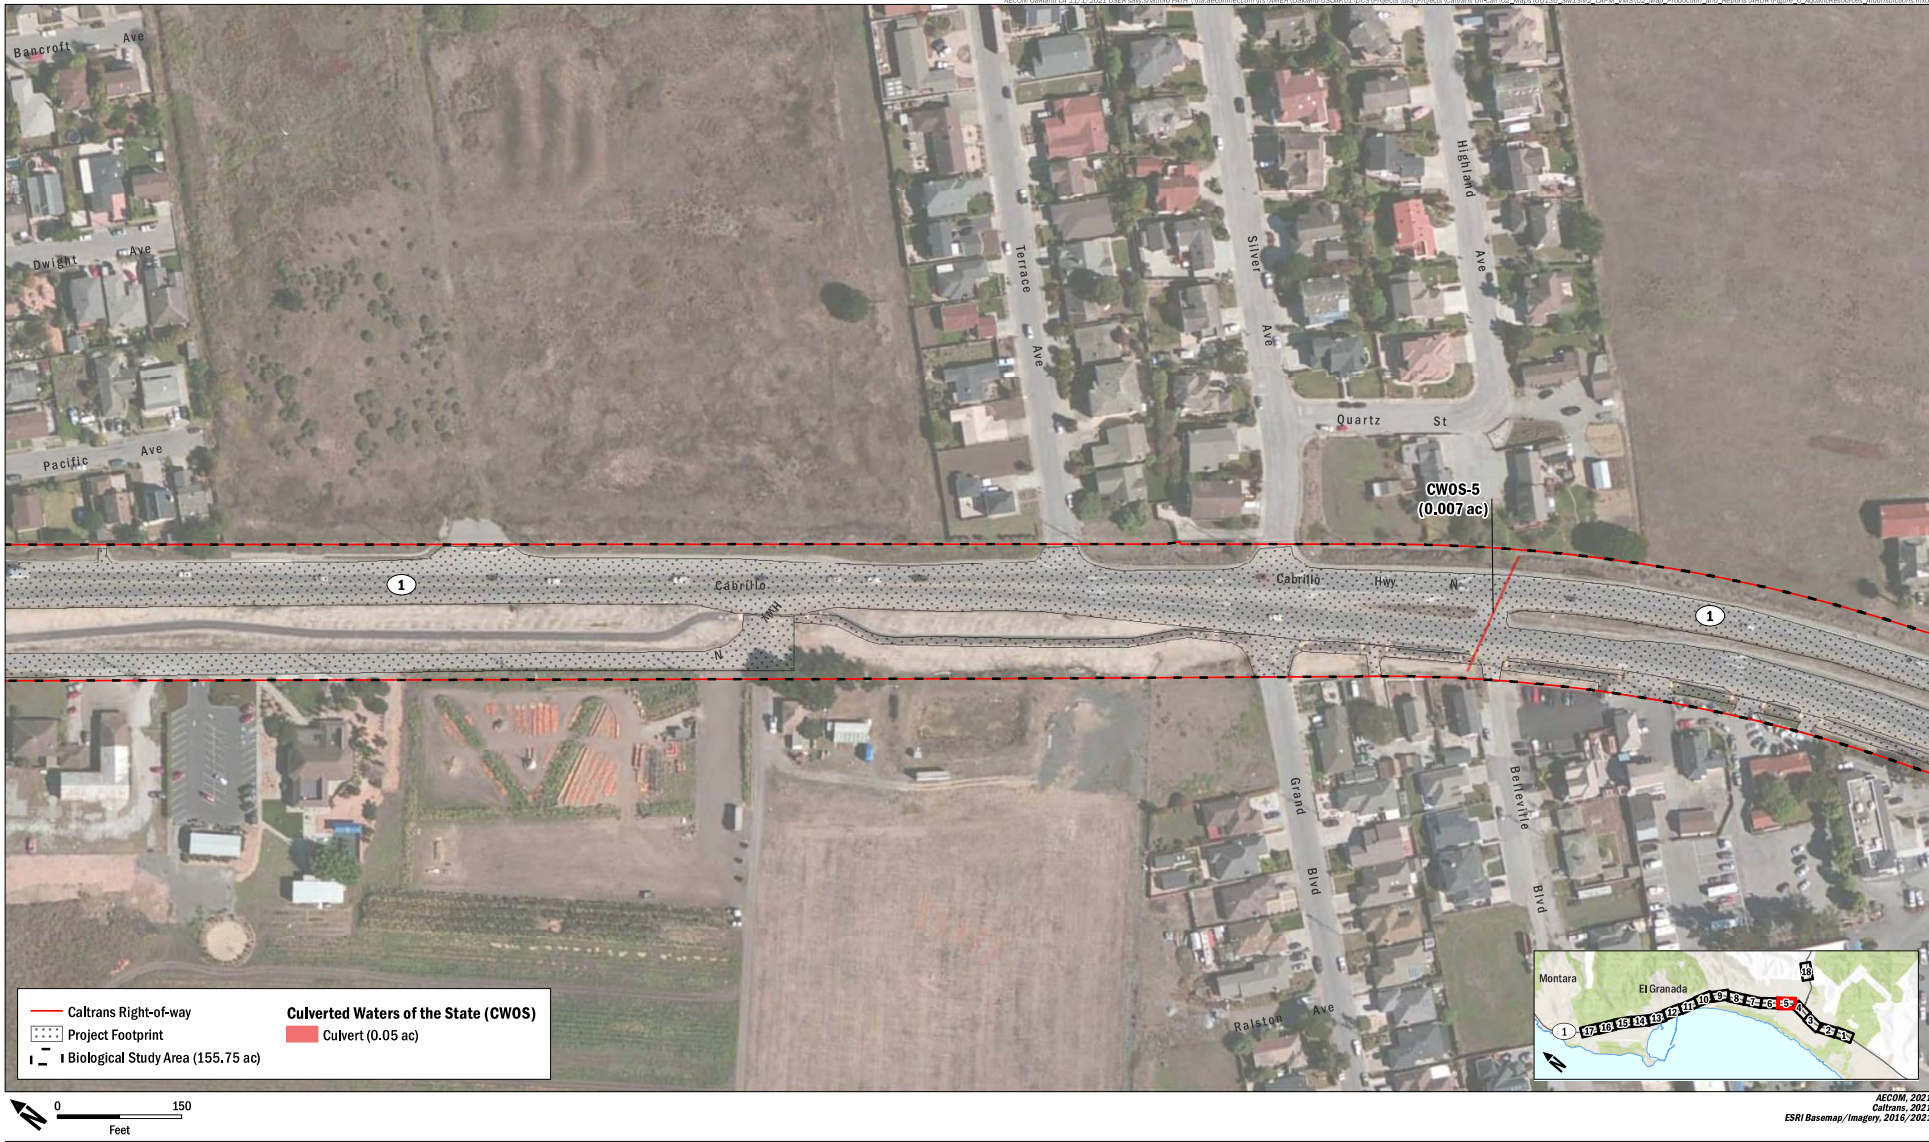
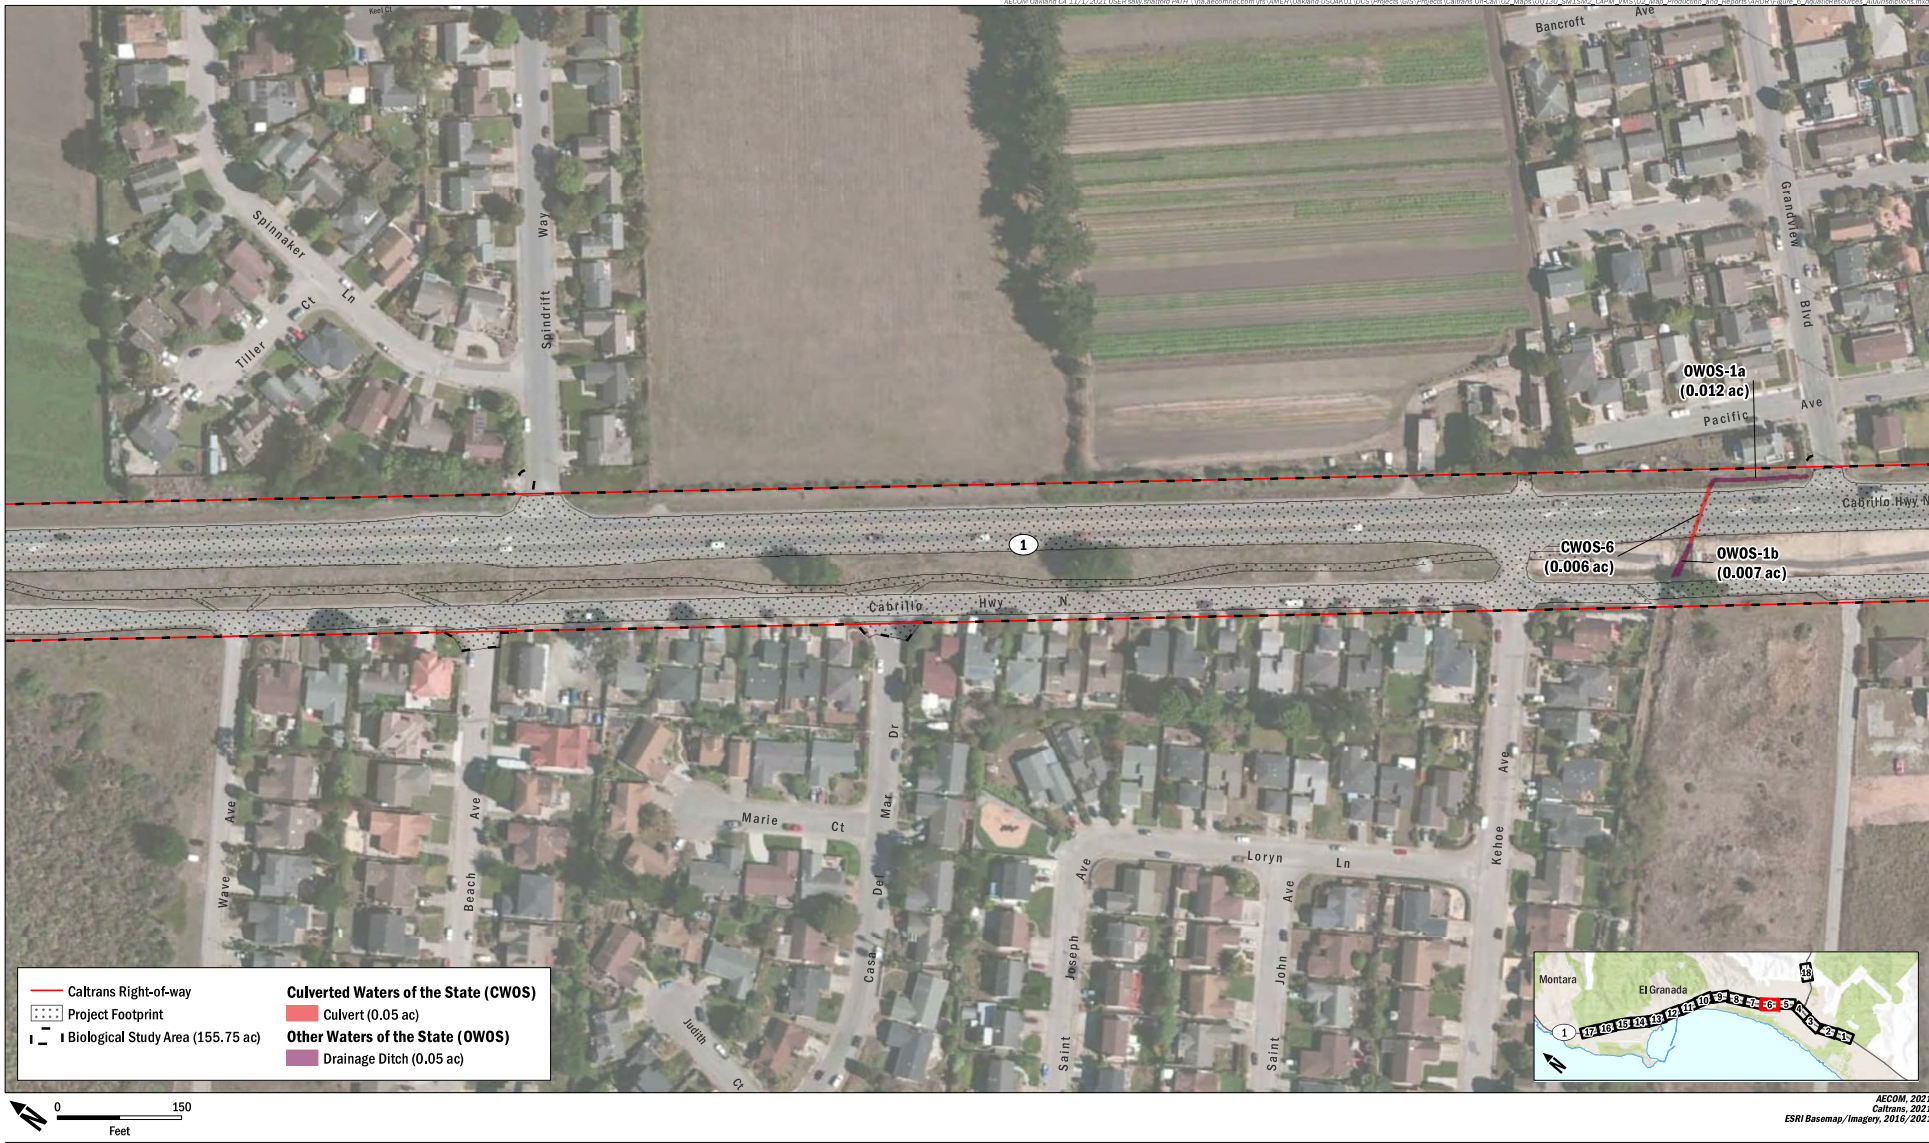
**FIGURE 6**  
 Wetlands and Waters of the United States,  
 Waters of the State, and Coastal Commission Wetlands  
 Page 1 of 18

Caltrans Right-of-way	Coastal Commission Wetlands (CCW)
Project Footprint	Riparian Woodland (4.30 ac)
Biological Study Area (155.75 ac)	Culverted Waters of the U.S. (CWUS)
	Culvert (0.09 ac)
	<b>Other Waters of the U.S. (OWUS)</b>
	Ephemeral Riverine (0.05 ac)
	Intermittent Riverine (0.38 ac)

There were 4.300 acres of potential coastal commission wetlands delineated in the BSA, in addition to the jurisdictional wetlands and OWUS, which are also considered coastal commission wetlands. These wetlands occur in areas that were found to be dominated by willows and riparian vegetation but lacked one of the three parameters required to be a USACE jurisdictional wetland. Figure 6 shows the potential coastal commission wetlands in the BSA that were delineated. Table 6 provides the total area of potential wetlands and riparian areas subject to CCC jurisdiction in the BSA that were delineated.
