# ARBORIST REPORT

**Inspection date: 10 / 18 / 2018**

**RE: Existing trees located on the proposed new construction site located at  
103 El Nido Road, Portola Valley, Ca. 94304**

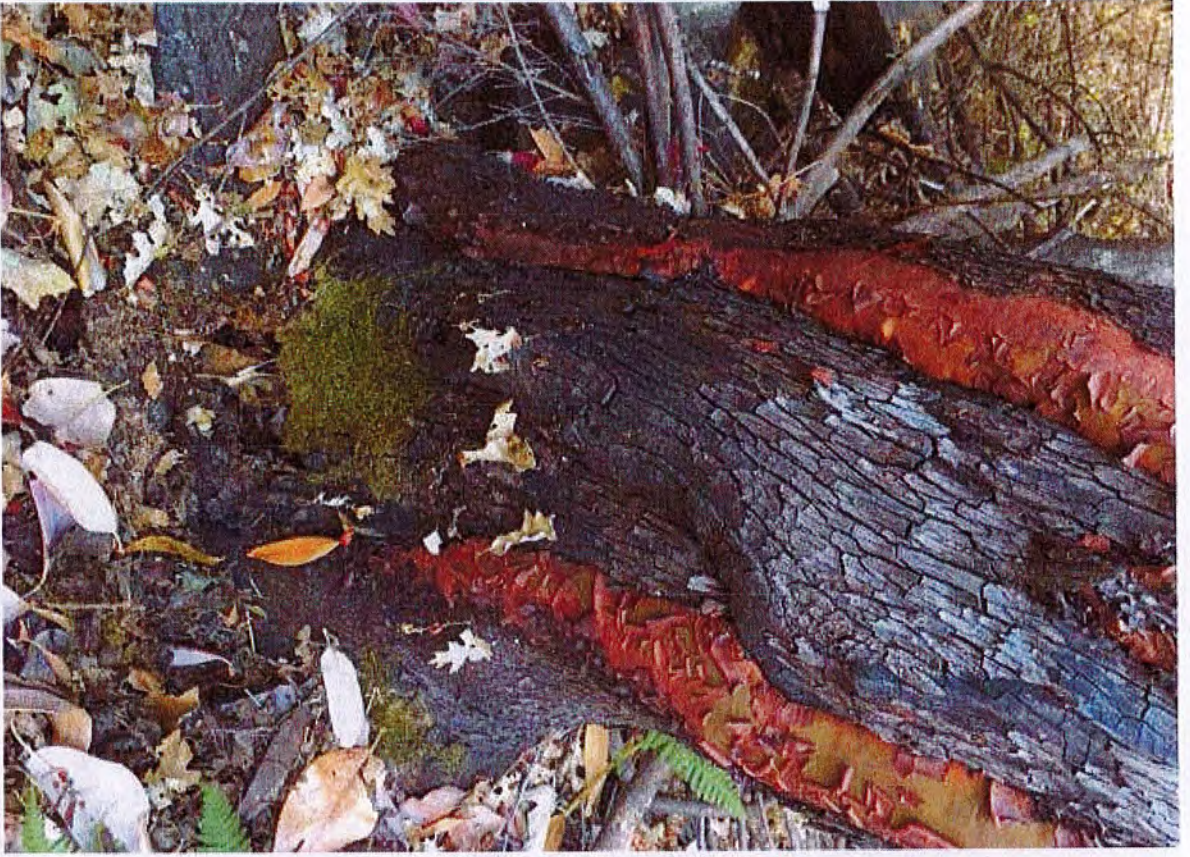
Exhibit 4-F

**Tree # 4 – Madrone (*Arbutus menziesii*) with a d.b.h. of 10" and approximately 30' tall. Foliage color appears fair and foliage density appears sparse. The tree has an excessive lean and a crook in the main stem @ 15'. The base of the tree exhibits excessive decay. (Exhibit 4 - F, G)**

**Tree # 4 - Madrone is diseased with excessive decay present at the base of the tree.**

**Should be removed to abate any future risk of failures and to accommodate the proposed new construction site.**
